# Ulster & Delaware Corridor Revitalization Study – Shandaken Section

Ulster & Delaware Corridor Revitalization Study –  
Shandaken Section  
Ulster County, New York  
Final Feasibility Report

**Prepared by**  
Barton & Loguidice, D.P.C.  
10 Airline Drive, Suite 200  
Albany, New York 12205

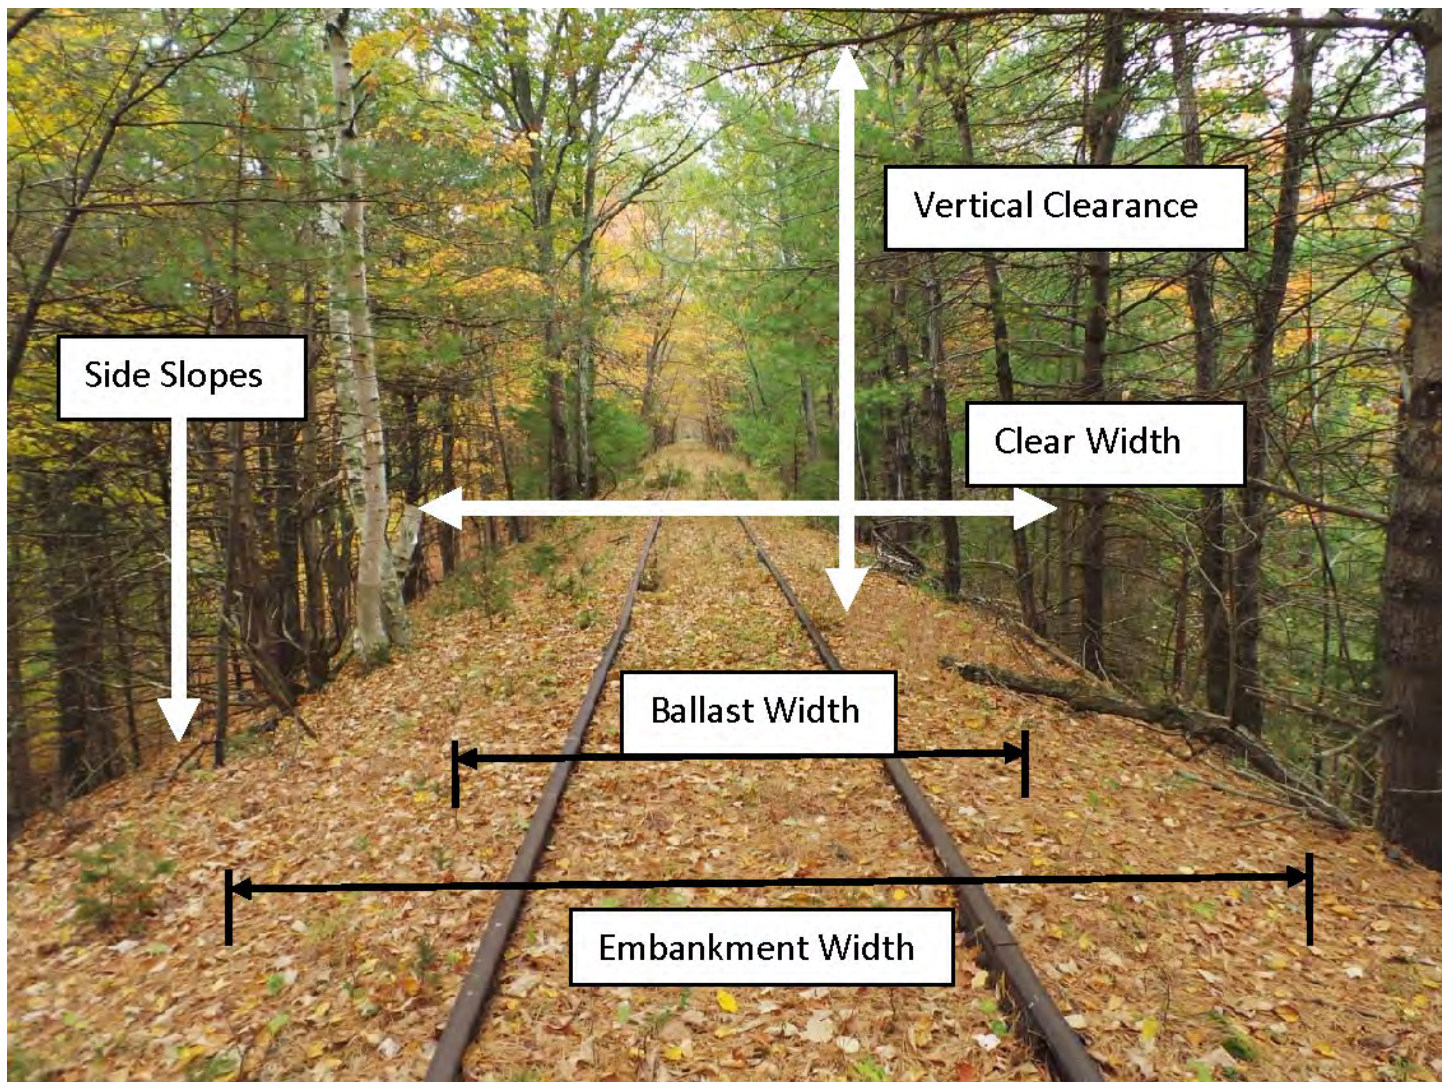
Figure 1-1: Corridor Dimensions & Measurements

Data such as the vertical clearance, clear width, ballast width, and the embankment width correlate with the image below. These measurements and collected data were used in the development of the preliminary cost estimate and is further discussed in Section 4.0.

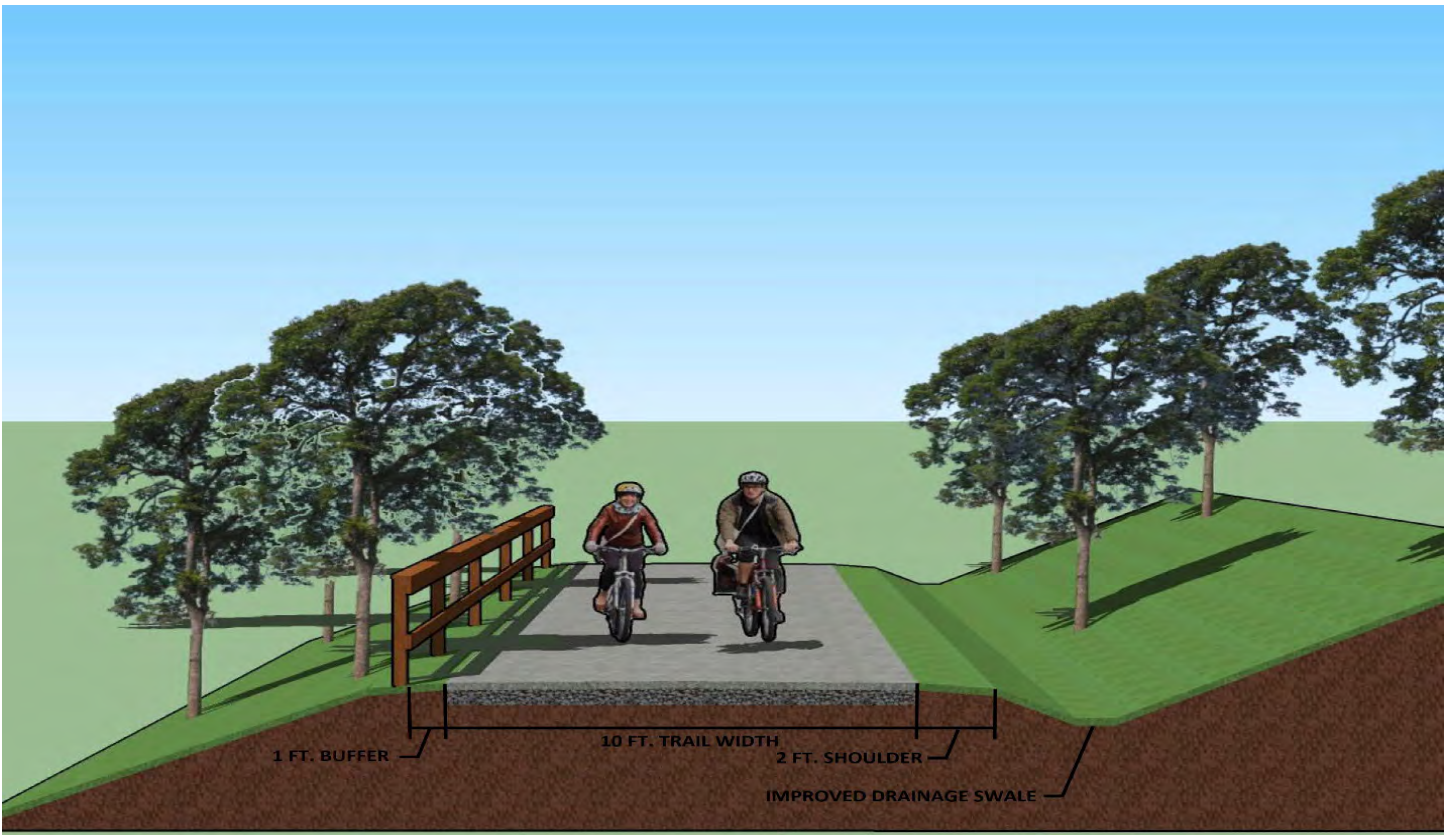
**Figure 1-2: Predominant Trail Corridor Section**

The predominant section through the corridor is as shown below with a drainage swale on the right side (assuming travel from Highmount to Big Indian) of the trail, a 10 foot crushed stone trail width, and a down slope on the left side of the trail with pedestrian safety railing.

According to the AASHTO guidelines, pedestrian safety railing a minimum of 42” in height should be included adjacent to the trail when a clear area of 5 feet at a maximum slope of 1:6 cannot be achieved and one of the following conditions are present:

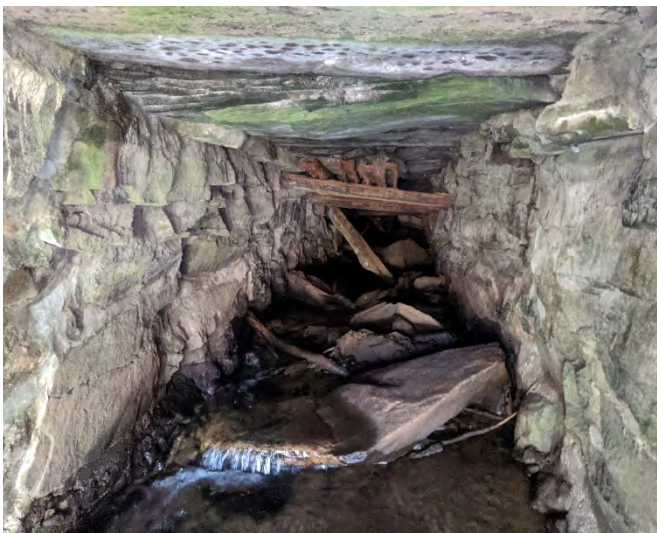
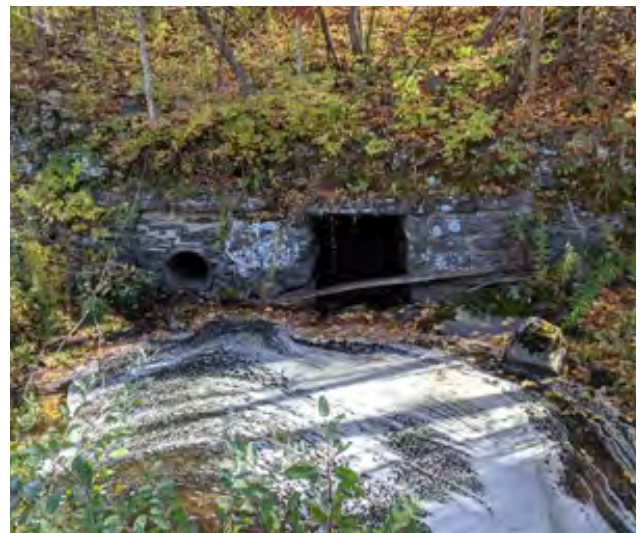
**Figure 1-6: Collapsed southern culvert with repair attempts and flowing water visible (left) and inlet of double barrel culverts flowing under railroad (right).**

One large culvert located near the Belleayre Mountain snowmaking reservoir and the double horseshoe curve should be replaced. This culvert is a side-by-side (double barrel) system constructed of stacked stone and mortar culverts with both originally measuring 5' x 5' at the outlet. The southern culvert is collapsed halfway through the culvert and repair attempts were made at one point to address the collapsing roof of the culvert by inserting steel railroad rails into the culvert. A large sinkhole has formed within the railroad tracks directly above this collapsed portion of the culvert. Daylight is not visible through the culvert, however, water does flow through the large voids in-between the stone within the culvert. The northern culvert has been repaired by insertion of a steel 24" diameter pipe approximately 75% of the way through the culvert. The original 5'x5' opening of the culvert was walled off with stone and mortar to direct flow into the pipe. The invert of this pipe is above the adjacent southern culvert pipe see Figure 1-3.

The steel sections of pipe have become separated resulting in a wavering flow line from end to end, rather than a straight line. This culvert carries the entire railroad tracks and embankment over the outlet of a snowmaking reservoir for Belleayre Mountain, which has twin 48" steel pipes that control the water elevation of the reservoir and outlet into the culverts under the railroad corridor. Rehabilitation of this culvert is not feasible due to the poor existing condition of the culvert. Therefore, replacement of the failed culverts is the recommended alternative. Options for replacement include a large concrete box culvert or three sided structure with a natural stream bed. The Town of Shandaken indicated that the Belleayre Mountain staff occasionally perform large volume water releases of the reservoir which could further erosion of the embankment if the existing condition of the culverts is not improved to allow water to flow freely below.

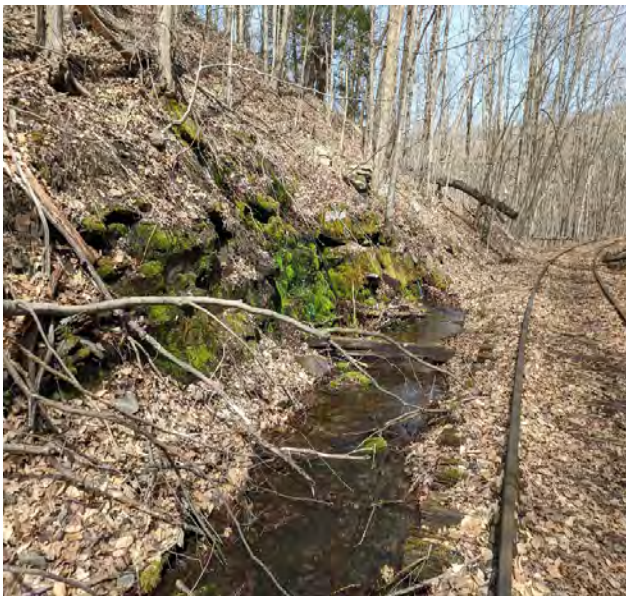
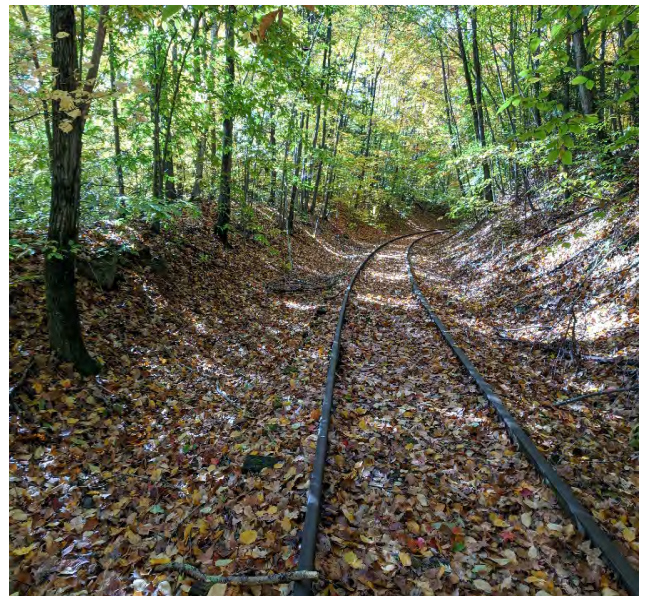
**Figure 1-7: Active stream at the double horseshoe curve (left) and dry swales with no apparent flows (right).**

Drainage swales were present throughout the majority of the railroad corridor but were poorly defined. The majority of the southwestern side of the corridor should have a properly functioning swale to convey potential runoff from the mountainside into the culvert pipes and away from the trail. Trees were present within the swales as well as significant debris accumulation. Most swales were dry and did not exhibit signs of flowing water during our field observations. However, active streams were observed within the swales in some locations such as at the double horseshoe curve parallel to the tracks near the Belleayre snowmaking reservoir at milepost K40.36. The stream has caused erosion and sediment transport of the ballast under the ends of the railroad ties. Disturbance to this stream should be limited and the trail potentially shifted or narrowed to avoid this water course. This stream is referenced as delineated stream 3 and is further discussed in section 3.0 along with the other streams that are jurisdictional by USACE or NYSDEC.

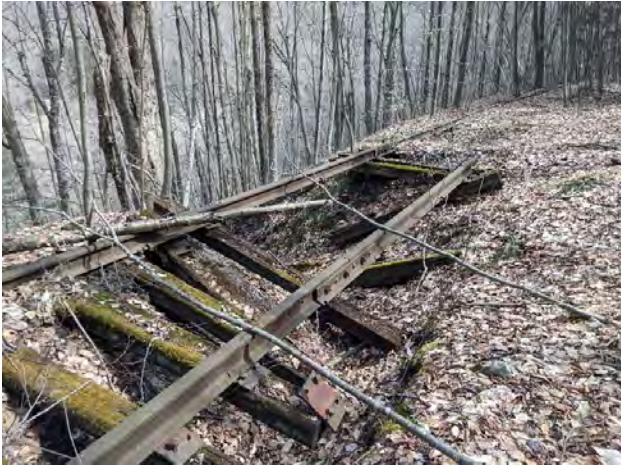
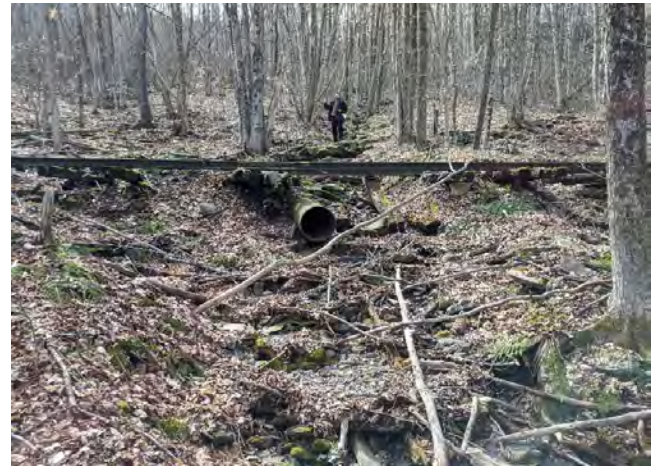
**Figure 1-8: Washout just East of Winding Mountain Road (left) and large washout at milepost K38 (right).**

Several washouts were found throughout the corridor and ranged in size from a few feet to nearly 40 feet in width. Repair of the washouts to establish a trail is dependent on the specific washout. If no flow is observed and the washout appears to have stemmed from an isolated storm event, the washout can simply be filled in with earth imported from an off-site location and compacted. The source of the flow that caused the washout will need to be investigated and either mitigated at the source or accommodated in the repair. In areas where the washout occurs in an active drainage channel, or within a clear seasonal drainage channel, a drainage pipe or culvert should be installed to convey any potential drainage flows that may re-enter the corridor in the future.

The above two photos depict the larger washouts found within the corridor. The photo on the left was taken just east of the Winding Mountain Road crossing where it appears that a one-time drainage flow entered the railroad corridor and washed out the ballast below the tracks for about 30 ft. before the flow turned down the side slope. A watershed analysis should be performed during the preliminary design phase to assess the likelihood that drainage flows could re-enter the washed out locations. If the washout is determined to be a one-time event, then washout could be repaired by adding fill to re-establish the desired grade. The photo on the right was taken at Milepost K38 and appears to be an intermittent stream that may only flow during large storm events. There is a defined stream channel both upstream and downstream of the crossing and the existing Pipe and a pipe upstream below a road are evidence that this is, or was at one time, part of an active stream channel. This washout likely occurred over several heavy storm events. Depending on the results of the watershed analysis, a large culvert pipe or a small concrete box culvert should be installed at this washout and a short portion of the stream should be realigned to carry the stream under the new trail.

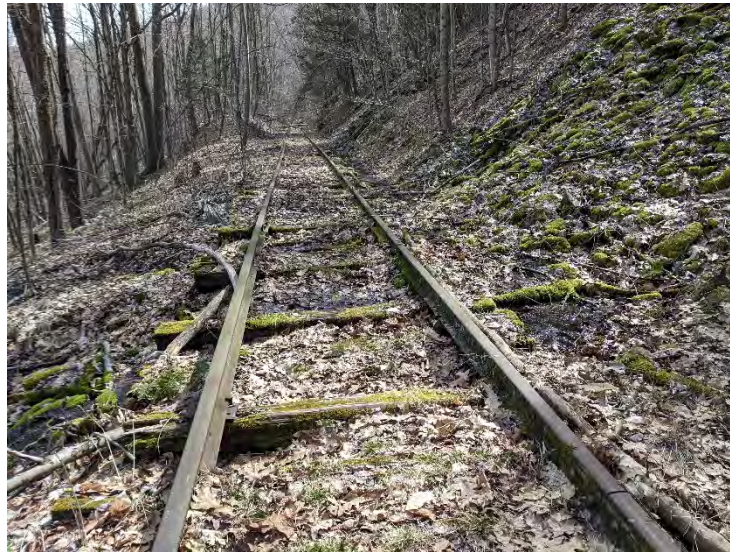
**Figure 1-9: Uncontrolled stream crossing west of milepost K39.**

Figure 1-9 shows an uncontrolled stream crossing approximately 20 ft. in length (measured along the tracks) where a mountain side stream flows between the railroad ties. The stream also collects along the right side of the tracks and flows parallel to the tracks for approximately 100 ft. before entering a culvert pipe below the tracks and outletting down the left side slope. In this location, excavating within the right side drainage swale or installing a culvert pipe where the stream enters the railroad corridor would properly convey the stormwater flows if. Alternatives to reduce impacts within the banks of the stream, if necessary to reduce stream impacts, could be completely spanning the stream and allowing it to maintain its full width below the new trail by installing a concrete culvert or short span low bridge.

A complete discussion of the potentially jurisdictional streams is located in Section 3. Culverts or pipes installed to control the stream may need to be 1.25 times the bank full width of the stream, which could lead to a large culvert crossing. In some locations, it may be advisable to install a low short span bridge over the flow rather than a concrete culvert.

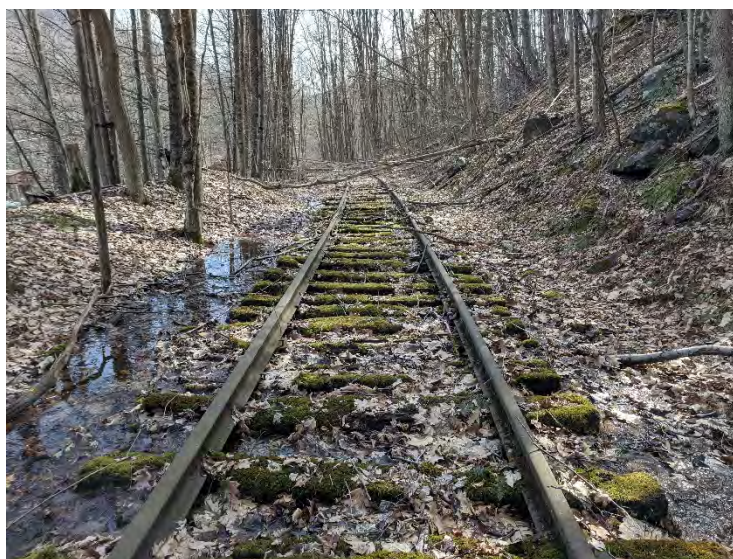
**Figure 1-10: Uncontrolled stream just west of Lasher Road.**

Just west of the Lasher Road overpass, the B&L team observed water flowing between the ties and parallel to the tracks within the rock cut. This water flow appears to be intermittent and was determined not to be a wetland or stream during our site visits. The saturated materials should be removed and replaced with a layer of geotextile fabric and large interlocking stone (1.5” to 3” in diameter) that will provide a solid foundation to accommodate construction and future maintenance or emergency vehicles. The drainage flows should be directed into re-established swales that run parallel to the tracks and away from the railroad corridor. The photo below shows the water in-between the railroad ties.

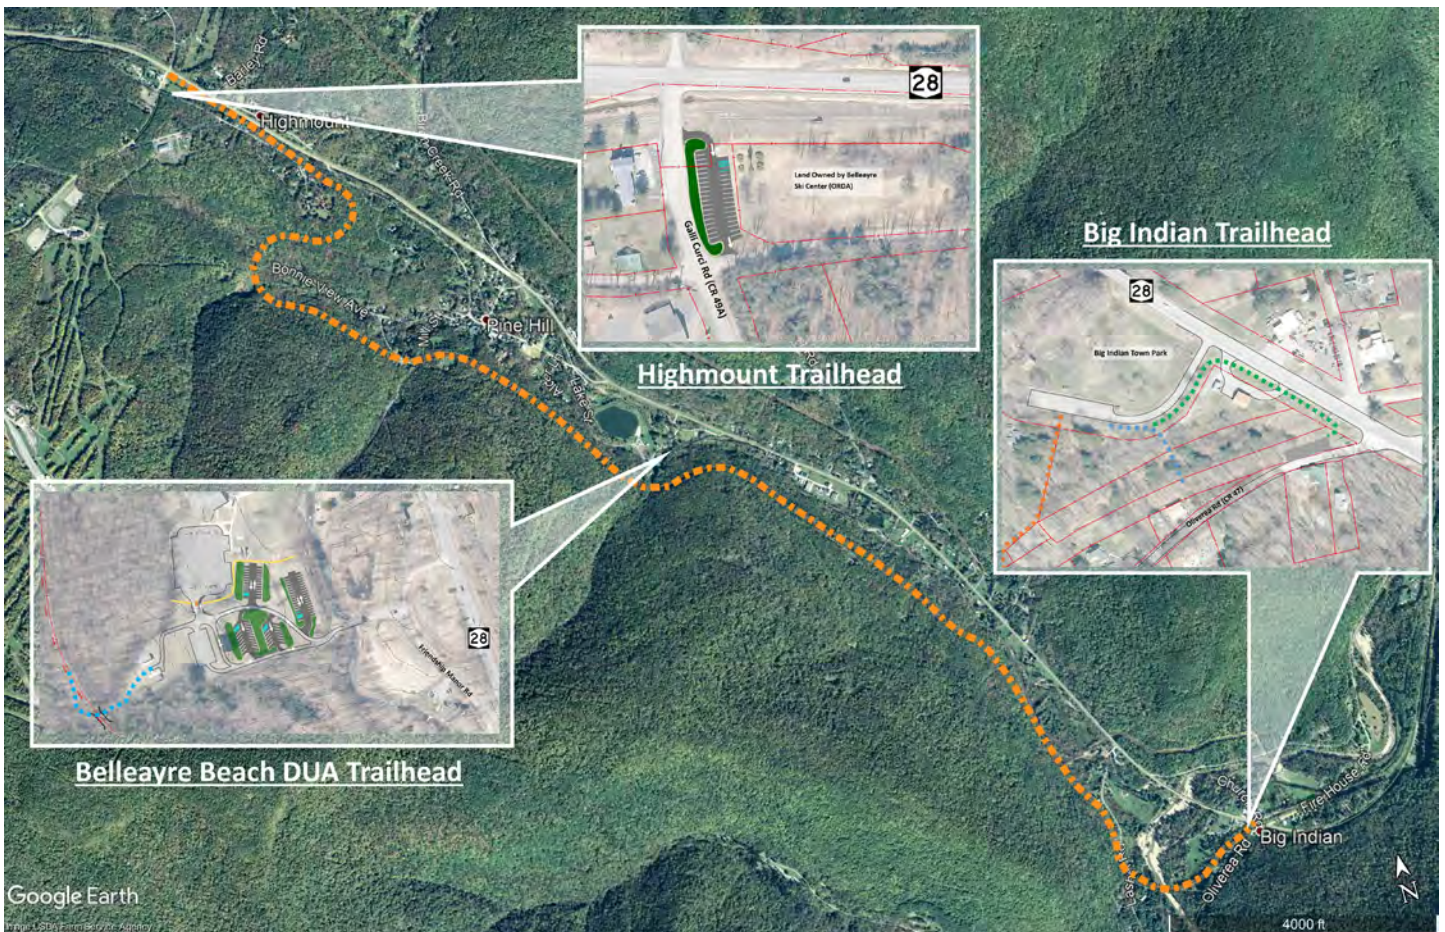
**Figure 1-11: Trailhead Location Map with conceptual drawings.**

There are three logical trailhead locations for the trail with two of the three locations offering easy access to the potential users and straightforward construction on land currently owned by Ulster County. From West to East, the locations recommended for trailhead are at the intersection of Galli Curci Road (CR 49A) and Route 28 in Highmount (adjacent to the Belleayre sign), at the Belleayre Beach Day Use Area in Pine Hill operated by ORDA, and at the Big Indian Town Park in Big Indian. The trailhead at the Belleayre Beach DUA is contingent on an agreement between the County and ORDA due to the configuration and operation of the facility. In the development of this feasibility study, coordination with ORDA has begun, and is expected that a mutual agreement that will compliment both facilities will be reached. See section 1.6.2 for additional discussion on this facility and ORDA’s operations.

Each trailhead should consist of a no-cost parking area for approximately 20-30 vehicles for people wishing to use the trail. However, this number of spaces is ultimately dependent on available land at each location. Overflow or alternate locations within the vicinity of the trailhead could also be identified and utilized if capacity is exceeded at each trailhead on a particular day. Asphalt pavement is the preferred parking lot surface as it offers the most stable and least maintenance alternative for parking area surface treatment and is easiest to plow in the winter. Asphalt also allows pavement stripes to be installed to delineate parking stalls to help encourage efficient unattended parking. Without typical parking stall delineation, users tend to park further away from adjacent vehicles which reduces the effective number of parking stalls within each parking lot. However, the trade-off is that asphalt is an impervious surface which will require stormwater management and likely green infrastructure facilities to be constructed to mitigate the stormwater runoff.

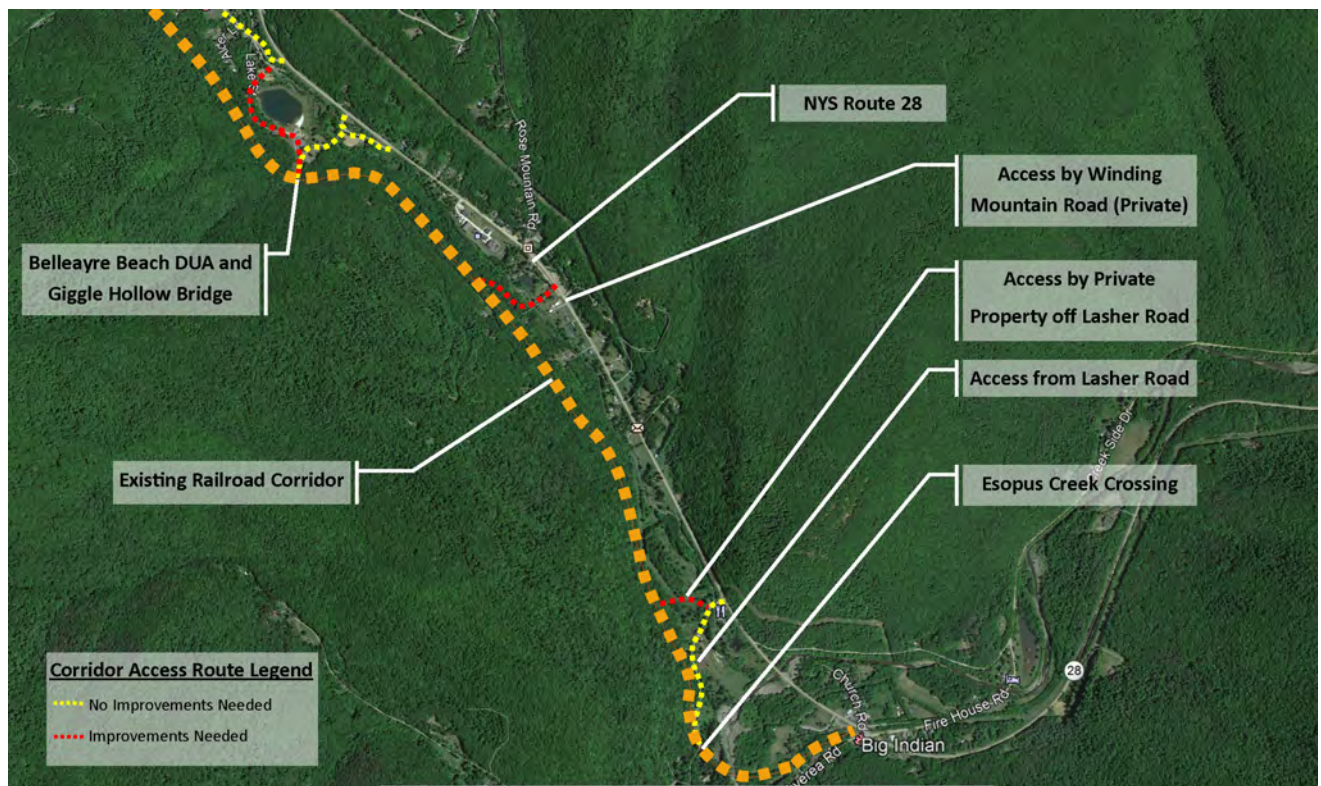
Figure 1-16: Construction Access on the East section of the corridor

Another feasible access location for construction vehicles is at the entrance to the Belleayre Beach DUA. A one lane steel girder covered bridge spanning the Birch Creek was constructed in 1992 and was constructed to New York State Department of Transportation standards at that time. The wooden cathedral-like cover or roof will need to be modified to allow larger construction vehicles to access the DUA and then the corridor. This location will also provide access to the Giggle Hollow Bridge and locations west of this site. Accessing the east side of the corridor will require construction vehicles to either cross the Giggle Hollow stream either via a temporary structure or by utilizing the railroad bridge. Modifications to the railroad bridge will be required for this to occur prior to use. An access road will also need to be cut into the slope adjacent to the railroad in order for vehicles to access the railroad corridor to the west. This access road could be permanent and provide an access for the trail users.

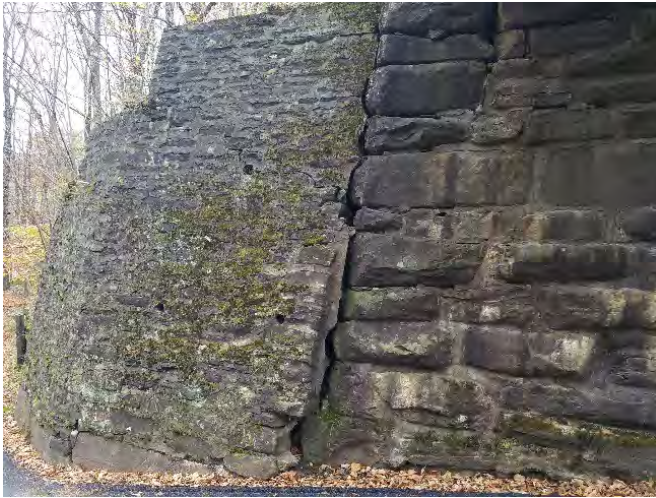
**Figure 2-4: Separation between East Abutment and Right Wingwall**

There is a crack at the mortar joint between the begin abutment and begin right wingwall. The northeast wingwall also has deterioration to the stone masonry in the form of two additional full height cracks, up to 1” wide. The southeast wingwall has collapsed behind the abutment and will require reconstruction. Overall, the stone masonry joint mortar is in fair condition. Approximately 30% of the surface areas of all substructures require repointing.

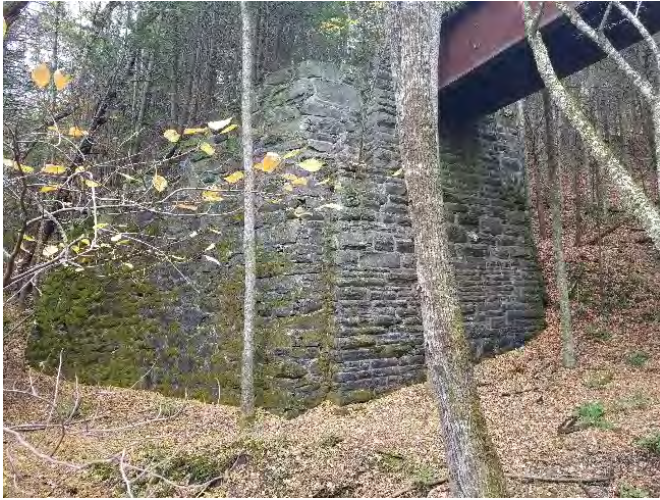
**Figure 2-6: Giggie Hollow Bridge East Abutment**

The masonry abutments appear in good condition, with localized areas of deterioration. The most significant areas exist at the west abutment and west wingwalls. There are locations at both west wingwalls where a joint crack exists through multiple layers of grout. The stone masonry in these locations appears to be tipping away from the embankment. There are also signs of joint separation at the northwest cheekwall between the

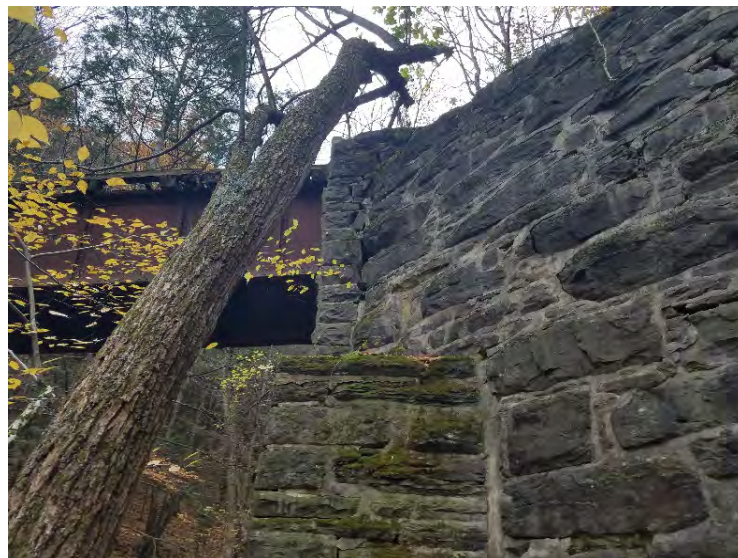
**Figure 2-8: Separation beginning at the joint between the cheekwall, backwall, and northwest wingwall at the West Abutment**

backwall and the wingwall at the west abutment, seen in the photo below. This is causing the stones in this location to tip and rotate away from the backwall. Overall, approximately 20% of the abutment and wingwall surface area has missing mortar between the stones.

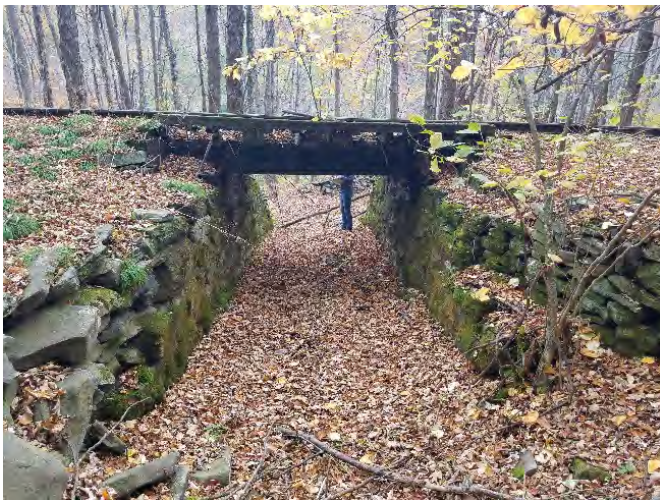
**Figure 2-9: View of the rails across the structure, looking south**

The stone masonry shows signs of deterioration, in the form of loose and missing mortar between adjacent stones, on approximately 50% the total surface area of each abutment and wingwall. The clear span between abutments is 8'-6".

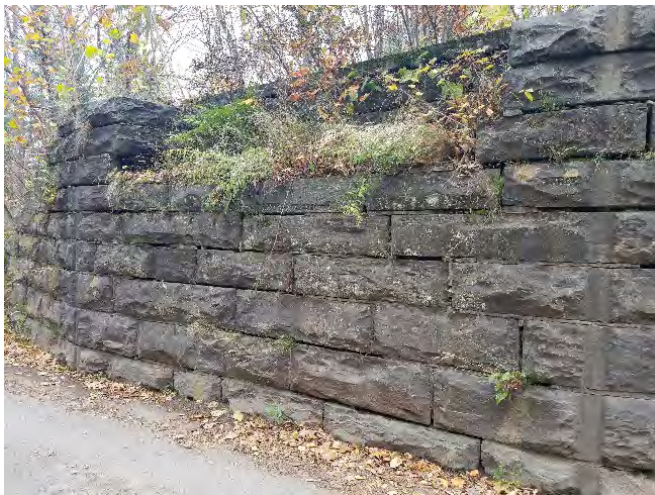
**Figure 2-11: Deterioration of the grout between the stone blocks**

The existing structure at the Lasher Road crossing consists of stone-block masonry abutments with no existing superstructure. The masonry stones at each abutment and wingwall are in fair condition; however, there is missing mortar between the masonry stones across nearly the entire surface area.

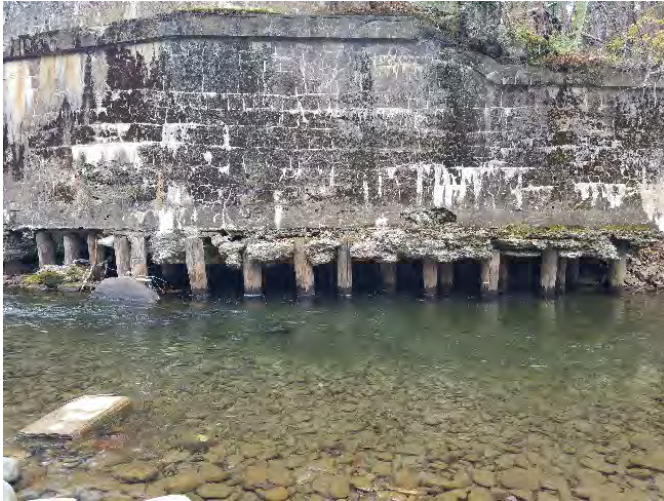
**Figure 2-13: West abutment deterioration due to scour**

The previous bridge that carried the Ulster and Delaware Railroad over the Esopus Creek sustained substantial damage in 2011 during Hurricane Irene and Tropical Storm Lee, and was later removed by the County. All that remains of the crossing today is the west abutment. The timber piles on which the west abutment was founded are exposed and show signs of severe scour. Based on the vegetation and sediment patterns on the shoreline, it appears that the former abutment locations were constricting stream flows through the bridge opening, resulting in the severe scour which can be seen in following photos. The existing span length of the previous bridge was measured to be approximately 90 feet. This was measured from the face of the west abutment to where the east abutment was assumed to be located.

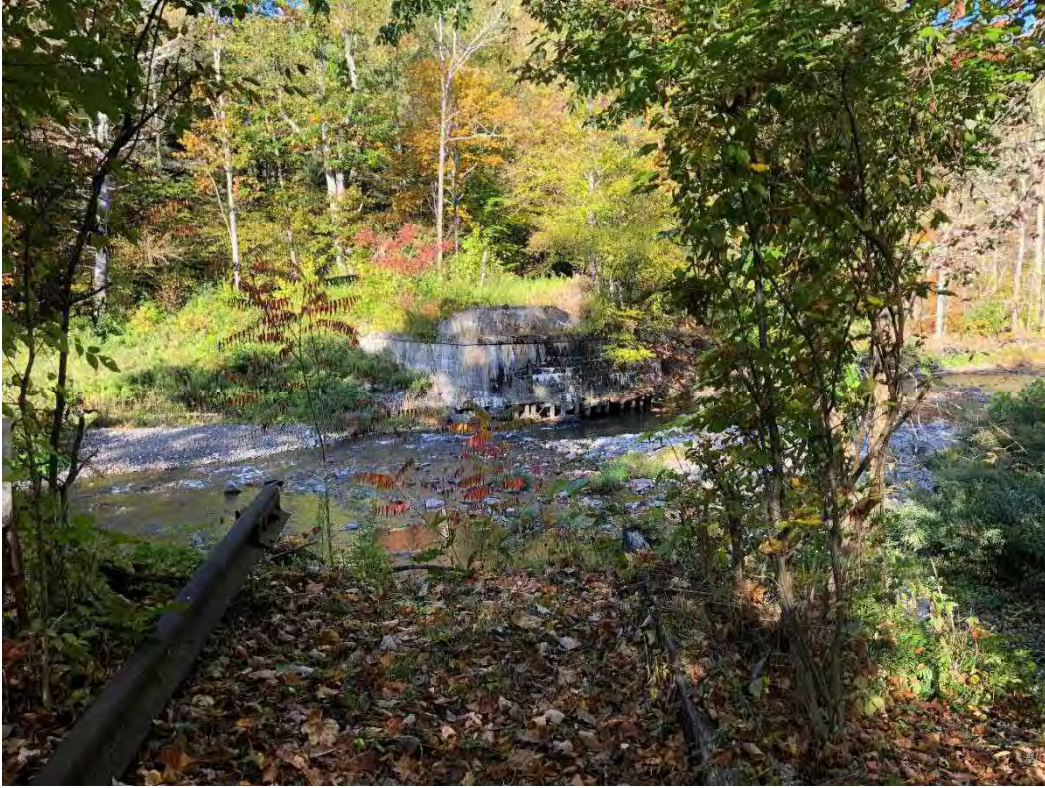
Photo 9. Esopus Creek bridge crossing; structure to be replaced.
