## Ulster County Road Safety Assessment Report (UC2016-091)

**Location 1:** NYS Route 212 – Town of Woodstock

**Location 2:** NYS Route 32 / NYS Route 212 – Town of Saugerties

**Location 3:** NYS Route 299 – Town of New Paltz

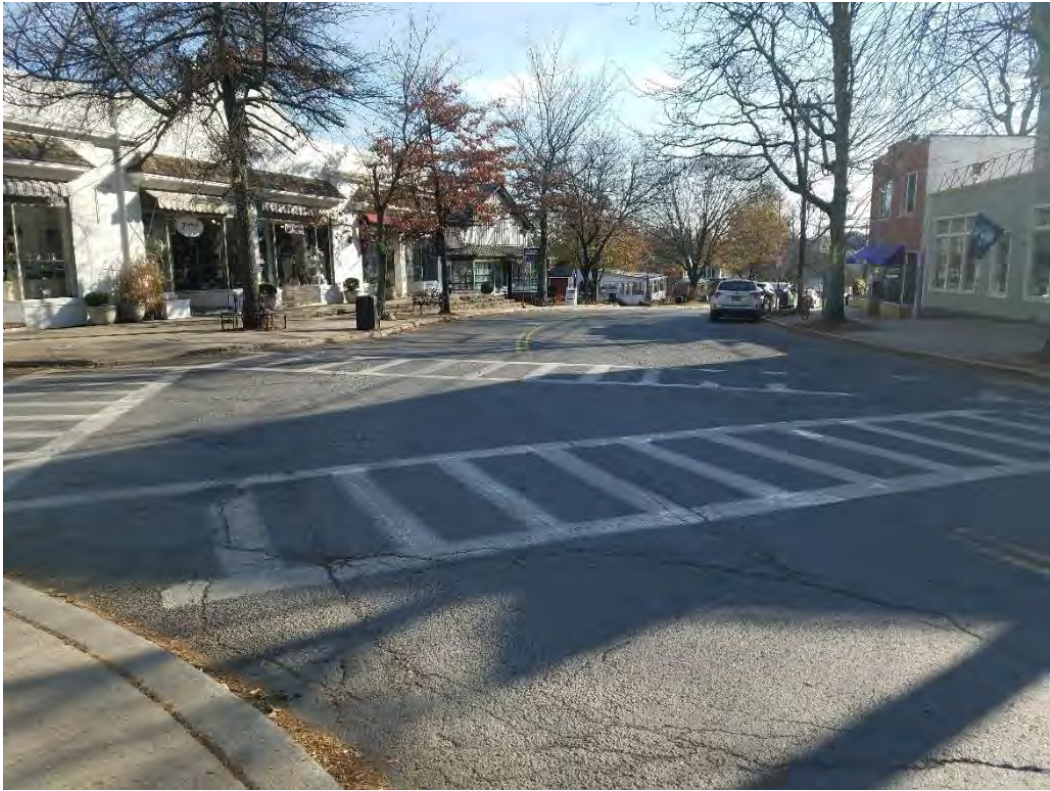
- In general, the roadway pavement markings (including double yellow, stop lines, & crosswalk markings) were found to be in poor to fair condition.
  - Delineation for on-street parking was non-existent. Motorists were found to be parked very close to intersections and driveways and were often found to not maximize use of available parking space. This condition makes turning movements to and from intersections and driveways more difficult, obstructs sight lines for turning motorists and results in an inefficient use of on-street parking.

- Crosswalk markings were faded and in poor condition. None of the crosswalk markings appeared to be striped using high-visibility and durable materials.

- The skewed alignments of some crosswalks are not ideal. Skewed crosswalks were found at Rock City Road, Maple Lane, and Deming Street. Crosswalks that are striped perpendicular to the roadway are ideal due to the minimized crossing distance.

**Photo 1:** View of faded pavement markings and diagonal crosswalks at Rock City Road.

- Utilizing durable, high visibility pavement marking materials and a yearly maintenance program would improve existing conditions and ensure that pavement markings are kept in good condition.

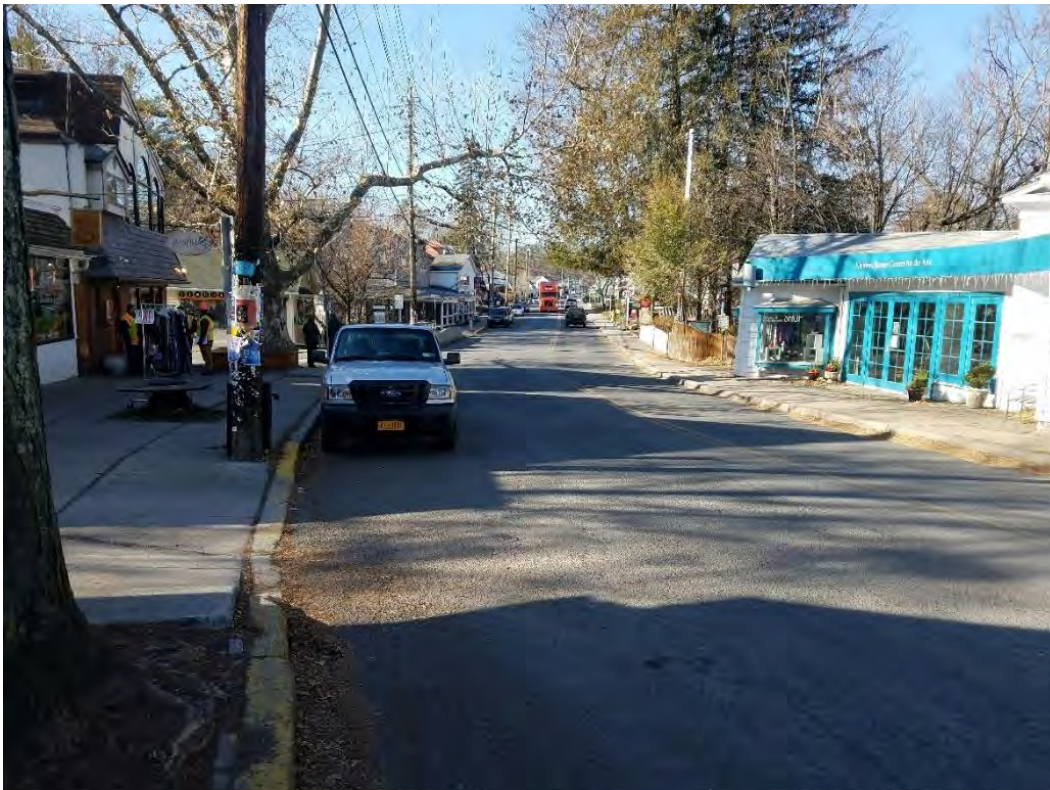
**Photo 2:** View of unmarked on-street parking along NYS Route 212. In addition, vehicle shown is parked within 20-feet of a driveway.

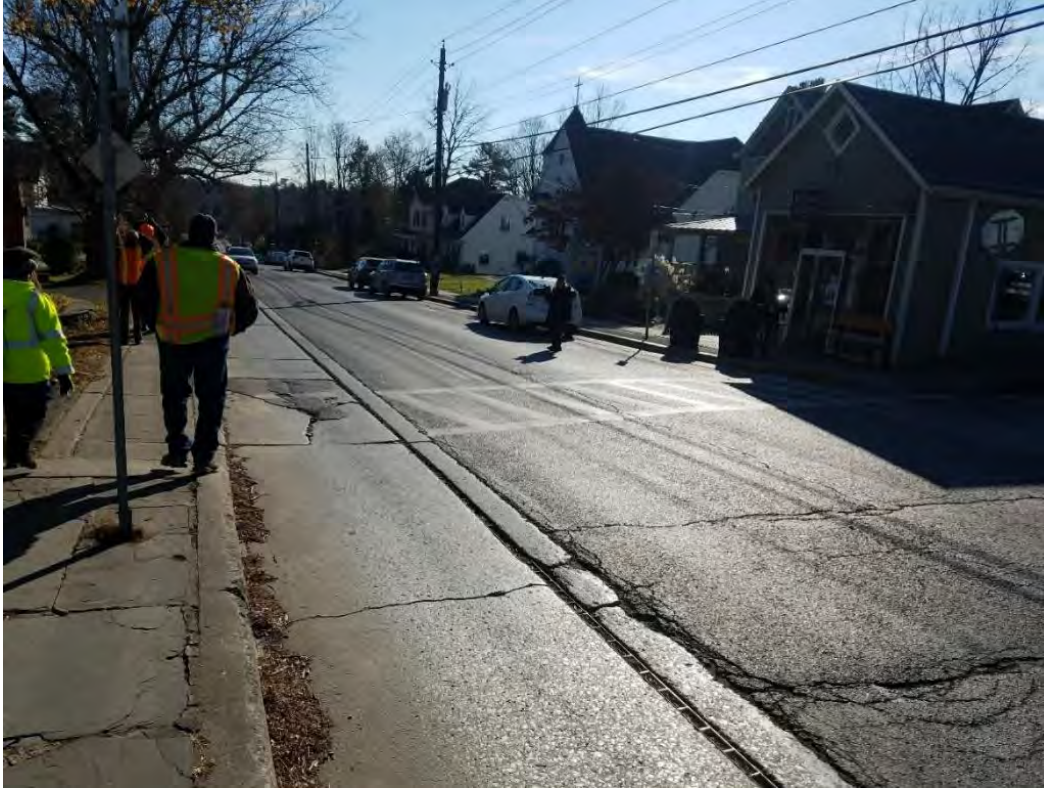
- The pavement surface was found to be in fair condition, except in the areas where trench drains were present and offset and along the north and south curb-lines east of Rock City Road.

**Photo 3:** Poor pavement condition in area where trench drain is present.

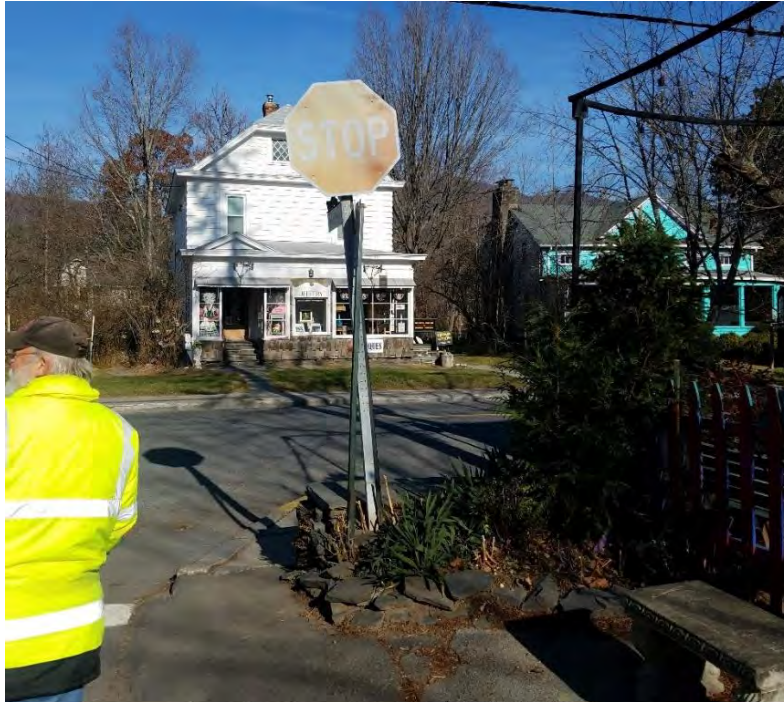
- In general, sign retroreflectivity and physical condition were found to be in fair to good condition except for a few instances.
  - There are instances of signs with faded panels that are in need of replacement. For example, the stop signs at Nehrer Street and Maple Lane and the “One Hour Parking” signs near Tannery Brook Road and Maple Lane are badly faded.

**Photo 4:** Faded stop sign at Nehrer Street.

- Replace worn out, faded and/or damaged signs.
- Re-orient parking related signage to the proper angle (between 30° and 45° facing the affected direction of traffic flow).
- Upgrade pedestrian crossing warning signs in accordance with NYSDOT PSAP guidelines and NYSDOT Standards. Enhanced treatments including yield markings and “Yield Here To Pedestrians” signs should be considered for the pedestrian crosswalk at the NYS Route 212 approached to Rock City Road due to the high level of pedestrian activity at this location.

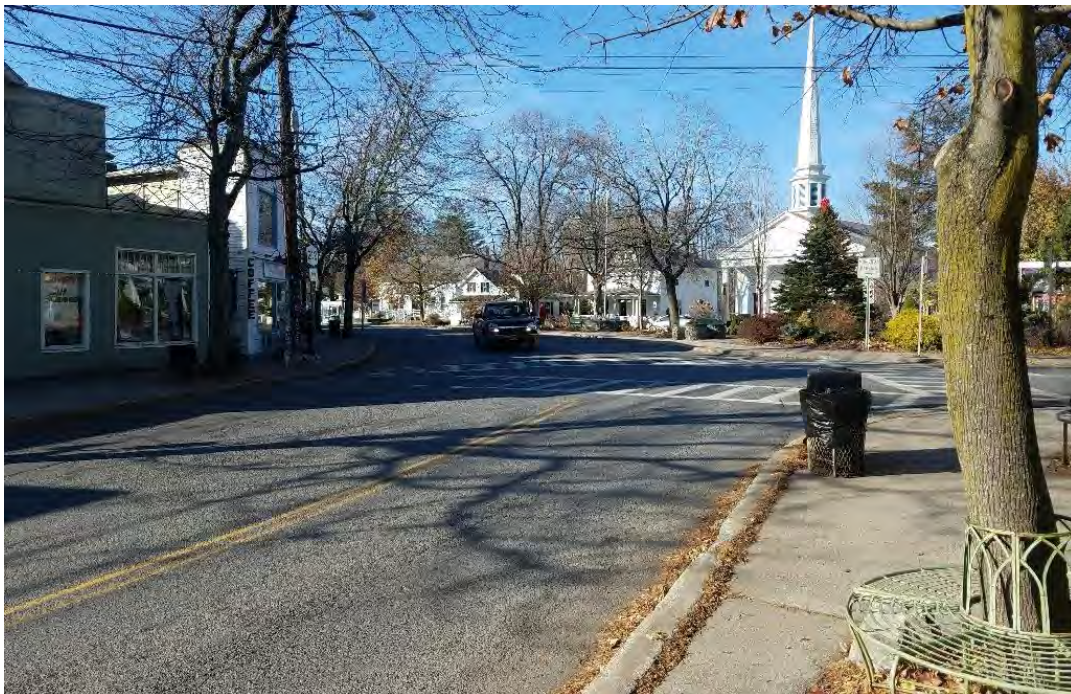
**Photo 5:** View approaching Rock City Road from the east. No pedestrian crosswalk warning signs.

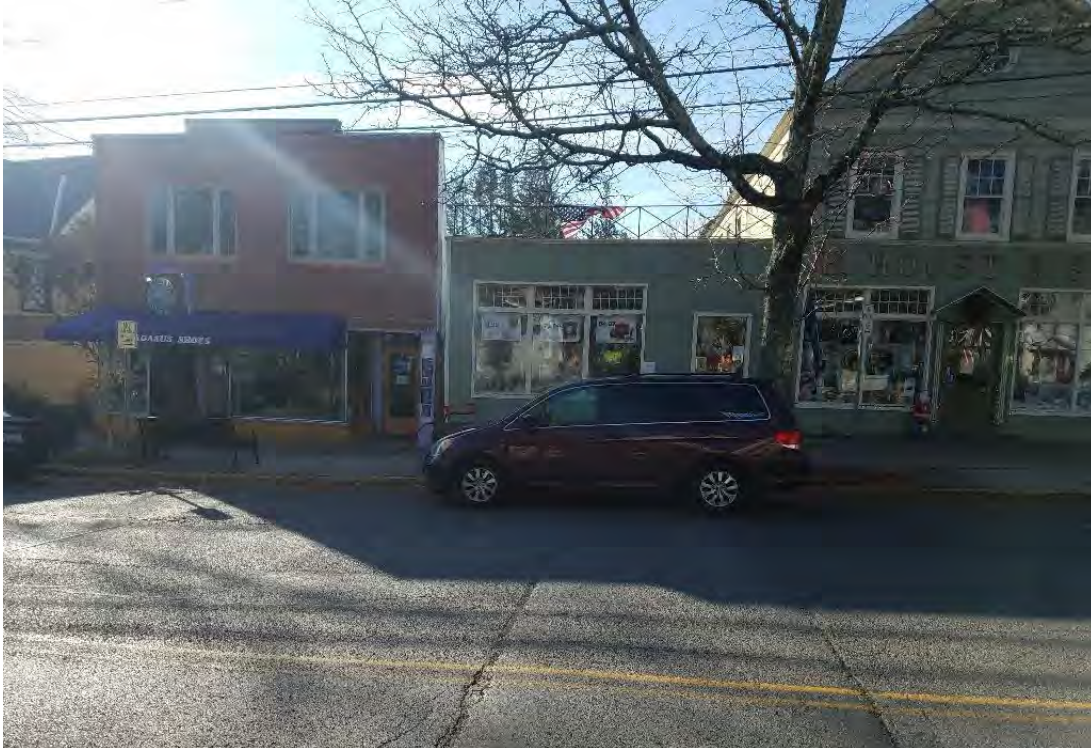
- Parking restrictions are often disregarded, and cars will often encroach into “No Parking” areas and areas too close to adjacent pedestrian crosswalks, side streets and/or driveways.
- Southbound motorists on Rock City Road ignore the “Do Not Block Side Road” sign and grid lock pavement markings at Old Forge Road.

**Photo 6:** Parked vehicle in no parking area near Rock City Road.

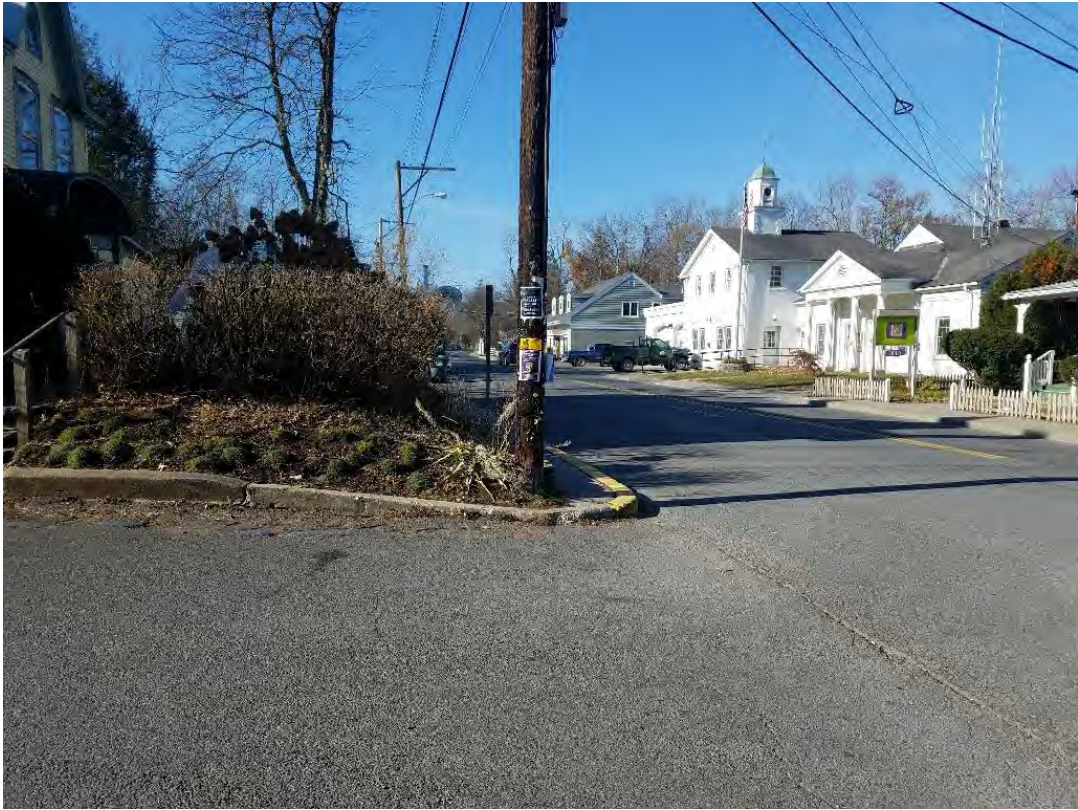
- Clear sight lines are often obstructed by parked vehicles, shrubs, banners, etc.
  - This creates poor conditions for motorists turning from side roads onto and off of NYS Route 212.
- Parking at the west end of the corridor is signed to be restricted for shorter time periods to provide for higher turnover use, but people remain parked longer than the 30 minutes permitted.
- Some drainage structures were found to be full of debris.
- Roadway lighting is present along the south side of NYS Route 212.
  - Lighting levels are moderate, but fixtures are not LED.
  - The north side of the intersection with Rock City Road is noticeably darker than the south side.

**Photo 7:** Shrubs obstructing sight lines at Nehrer Street.

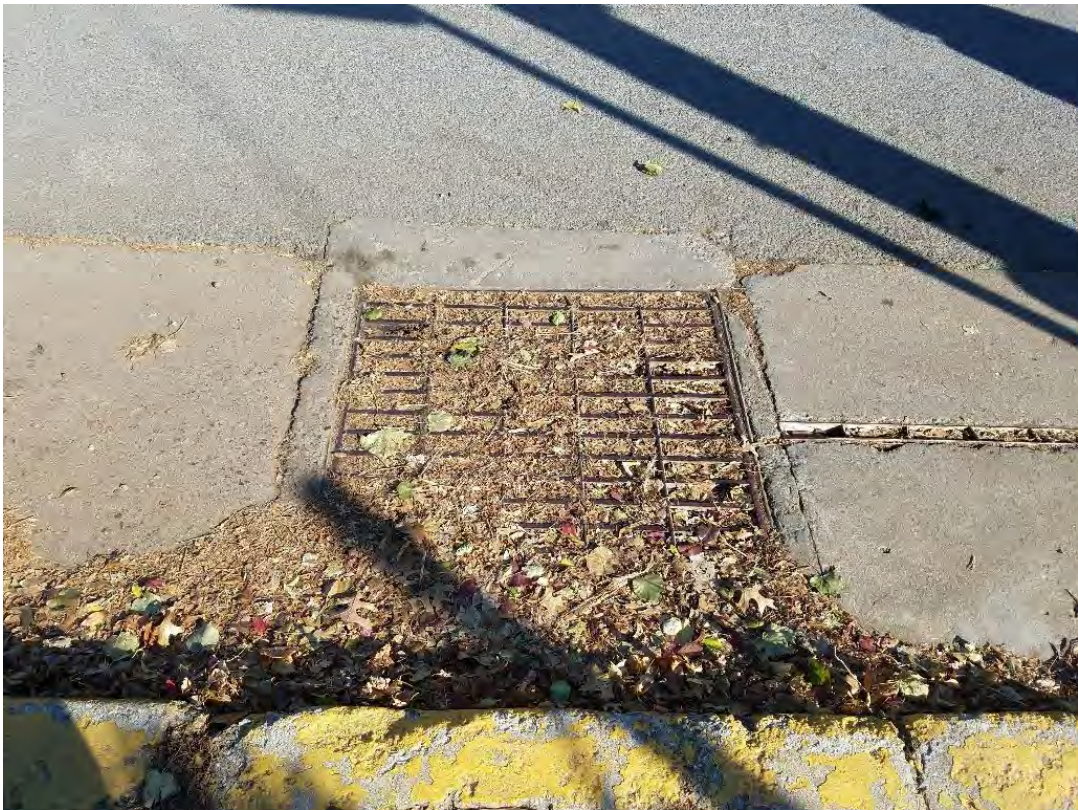
**Photo 8:** Drainage structure full of debris near Maple Lane.

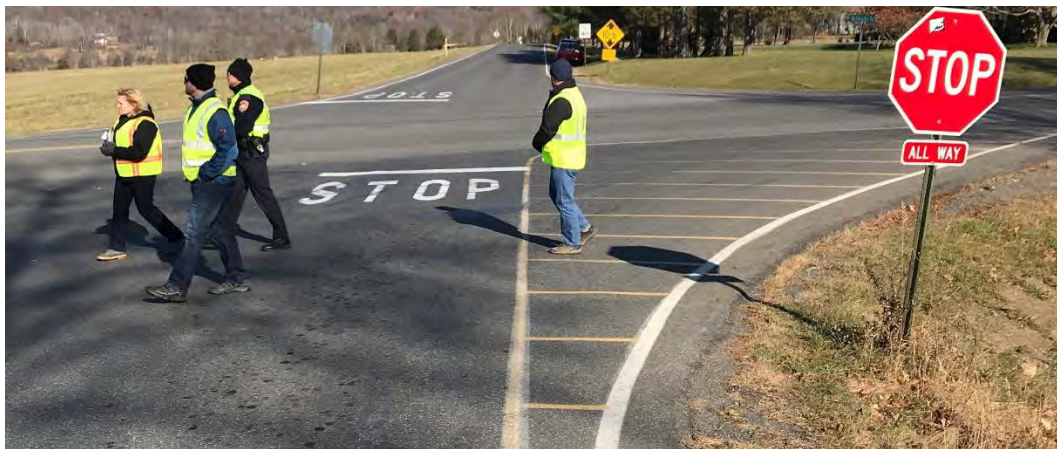
- In general, the roadway pavement is in good condition with the following areas having some minor degradation:
  - Just east of Jenkins Road.
  - Approximately 1000-feet west of Butternville Road/Albany Post Road.
  - Approximately 1000-feet west of Gate House Road.
- Generally, the pavement markings are in good condition throughout the study area.
- Four-foot wide shoulders have recently been added on each side of NYS Route 299 from Butternville Road/Albany Post Road to the eastern terminus of study limits. Four-foot wide shoulders are planned to be added along NYS Route 299 throughout the rest of the study limits. This will provide a safer condition for bicyclists traveling through the area.
- The channelized crosshatch markings at southeast corner of the NYS Route 299 and Butternville Road/Albany Post Road intersection are yellow (they should be white) and slightly faded.

**Photo 9:** Faded yellow channelized crosshatch markings on NYS Route 299 at Butternville Road.

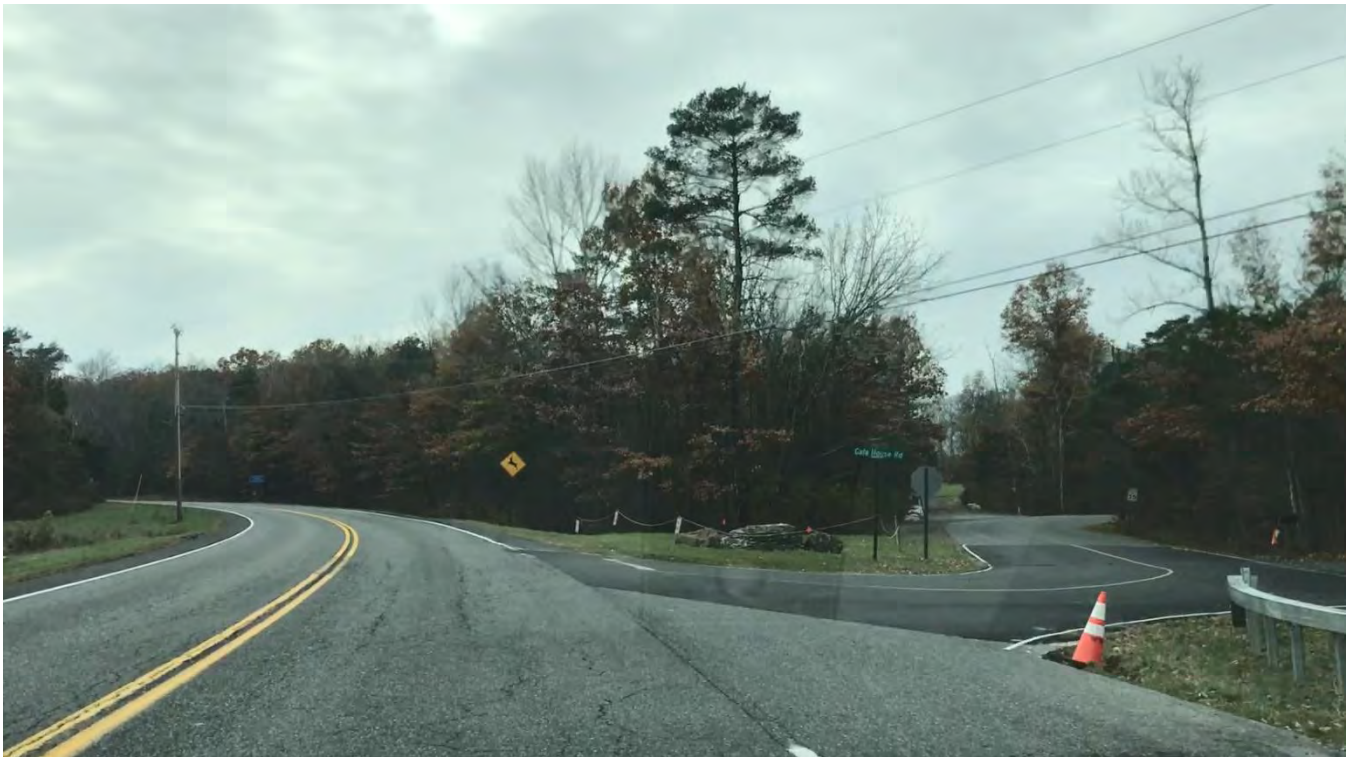
- Pavement and striping improvements at the Gate House Road approach to NYS Route 299 were recently incorporated, but the radii at the northeast corner of the intersection makes westbound right turn maneuvers difficult, especially for larger vehicles. It was observed that many vehicles cross over the yellow center line on Gate House Road while performing this maneuver.

**Photo 10:** Tight right turn radius at Gate House Road (in vicinity of traffic cone).

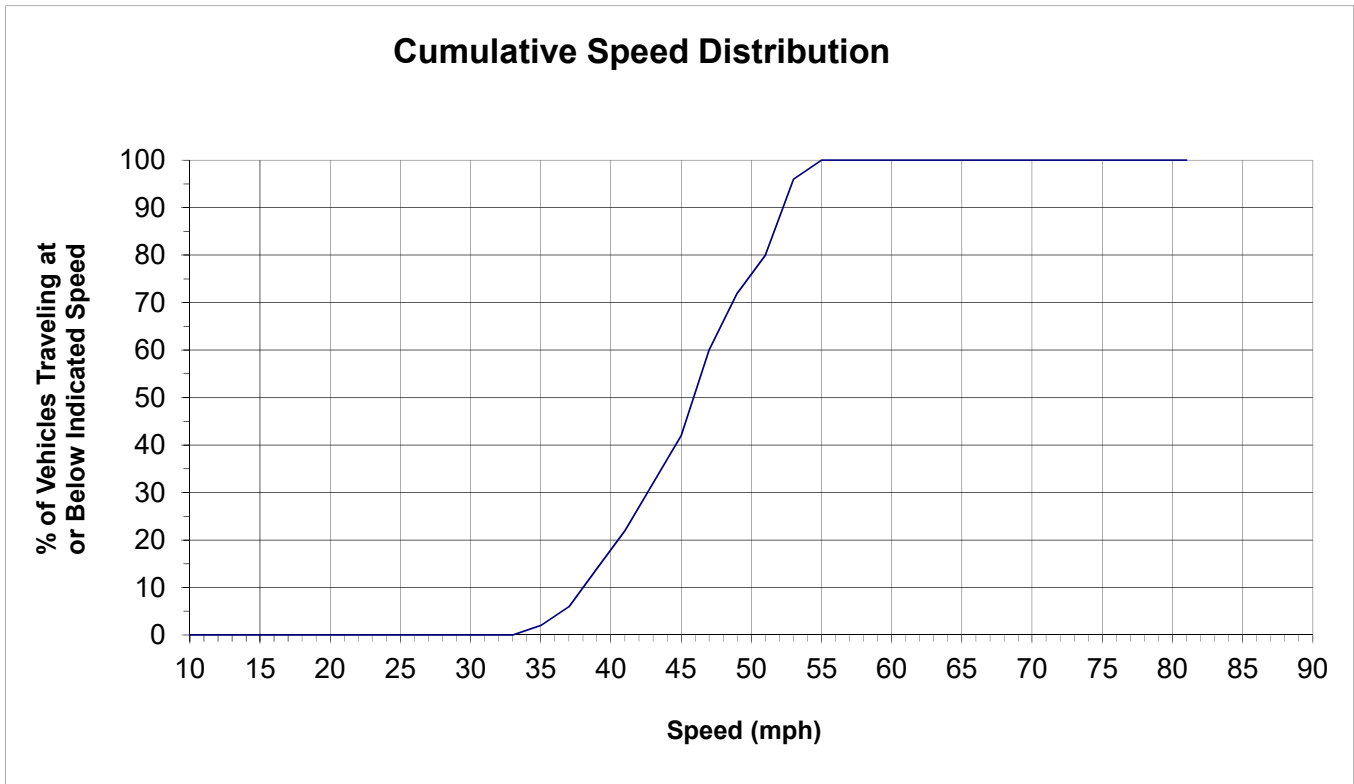
**Frequency Distribution for Spot Speed Study**  
**Location 3: NYS Route 299 approximately 500 feet east of Jacobs Lane**  
**Westbound**

**Note:** Data was collected on November 14, 2017 (Tuesday) from 10:00 AM to 11:00 AM

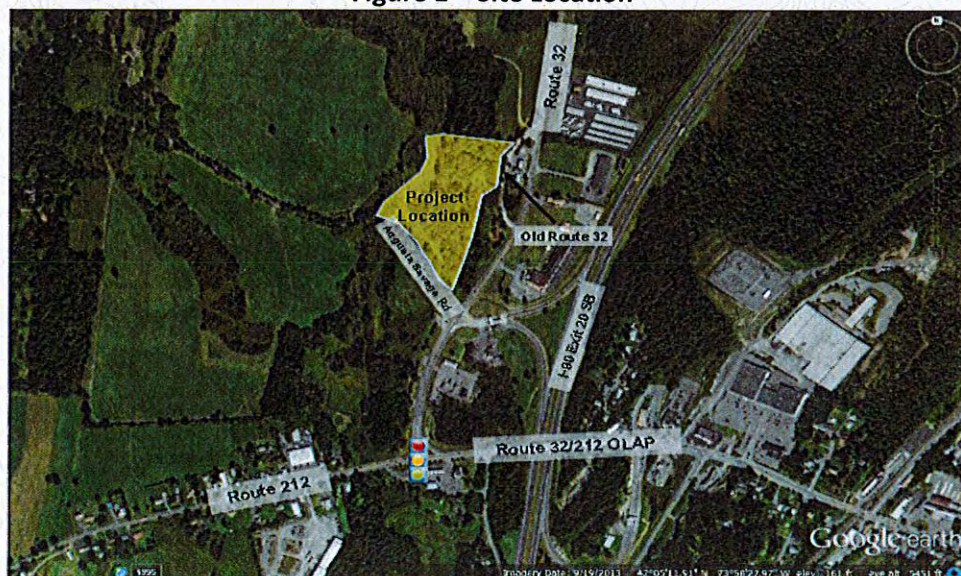
**Figure 1 – Site Location**

The project is located on approximately 10 acres of land west of Old Route 32 with primary access across from the Sunoco Gas Station on NY Route 32, which is approximately 1,200 feet north of the I-87 Exit 20 southbound toll plaza. Old Route 32 intersects NY Route 32 at two unsignalized locations separated by approximately 800 feet. The preliminary site plan (Attachment A) assumes a 100 seat sit-down restaurant, 86 room hotel, and a  $\pm 2,800$  square foot (SF) fast food restaurant with drive thru. A fourth building is proposed that will either be a second  $\pm 2,800$  square foot (SF) fast food restaurant with drive thru or bank with drive thru. It is estimated that the project will be completed and occupied in 2016, however, an initial phase of just the hotel use may be initiated prior to the remaining uses.

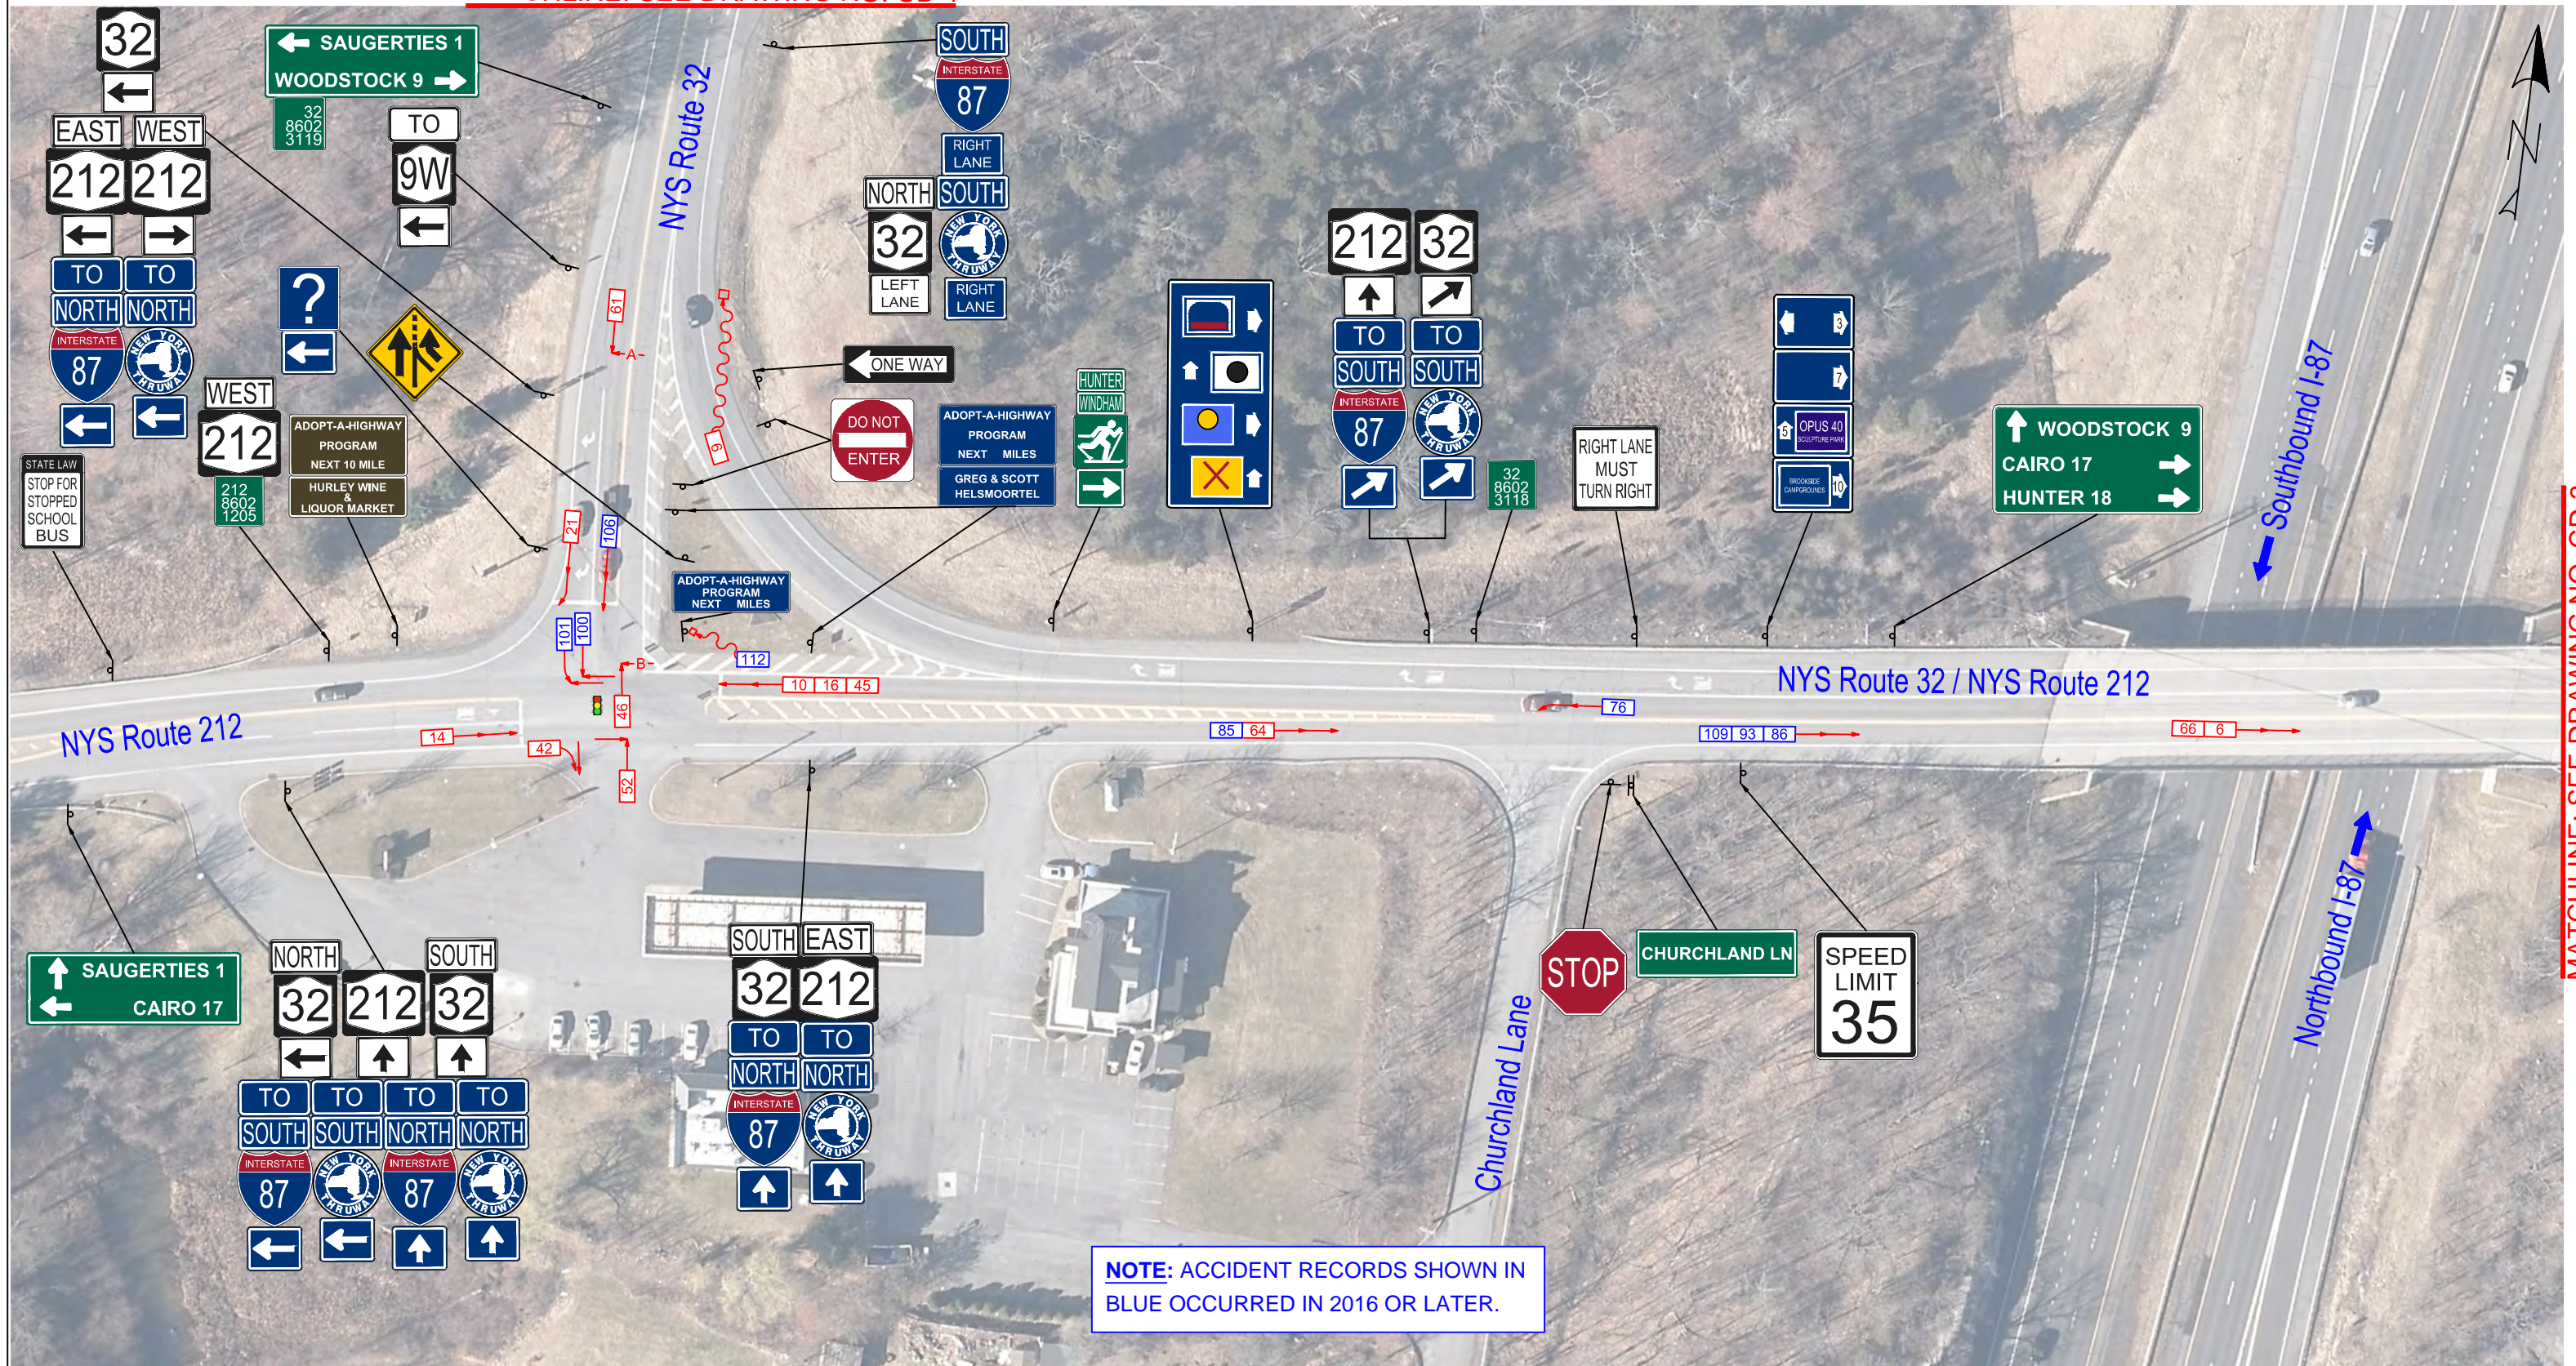
NOTE: ACCIDENT RECORDS SHOWN IN BLUE OCCURRED IN 2016 OR LATER.
