Kingston Rail Crossing Study

Evaluate and Enhance Safety along the West Shore Railroad Corridor

FINAL REPORT

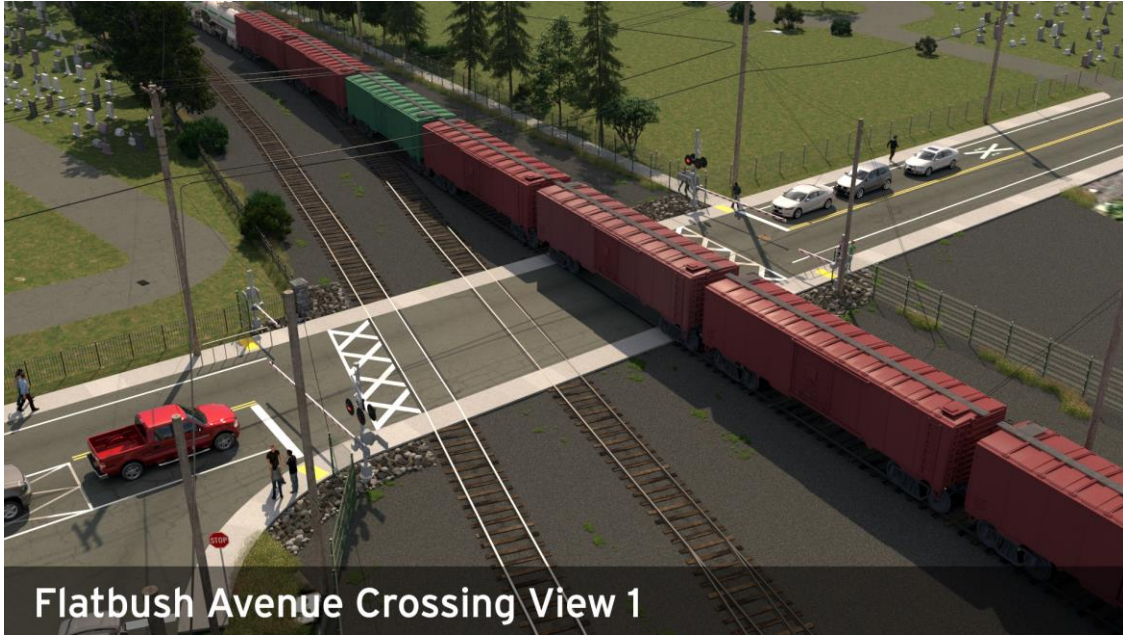
Flatbush Avenue Crossing View 1

- ▶ The City of Kingston with support from Ulster County and NYSDOT, as needed, should provide upgrades and safety enhancements to all eight highway Rail Grade Crossings and associated pedestrian pathways. These improvements would include, dynamic envelope markings, pedestrian sidewalks gates and pavement markings, center lane delineators as further defined in this report and represented in the following renderings.

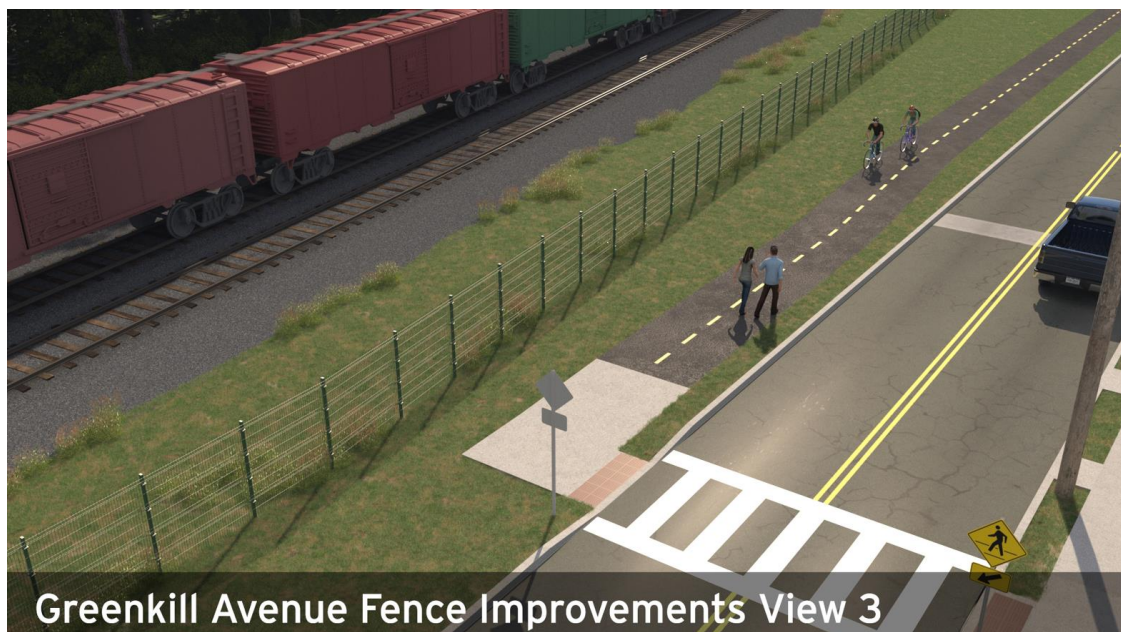
- Replace the chain link fencing just south of Broadway along Greenkill Avenue with high strength security fencing that extends 500 to 1000 yards in each direction, if possible.

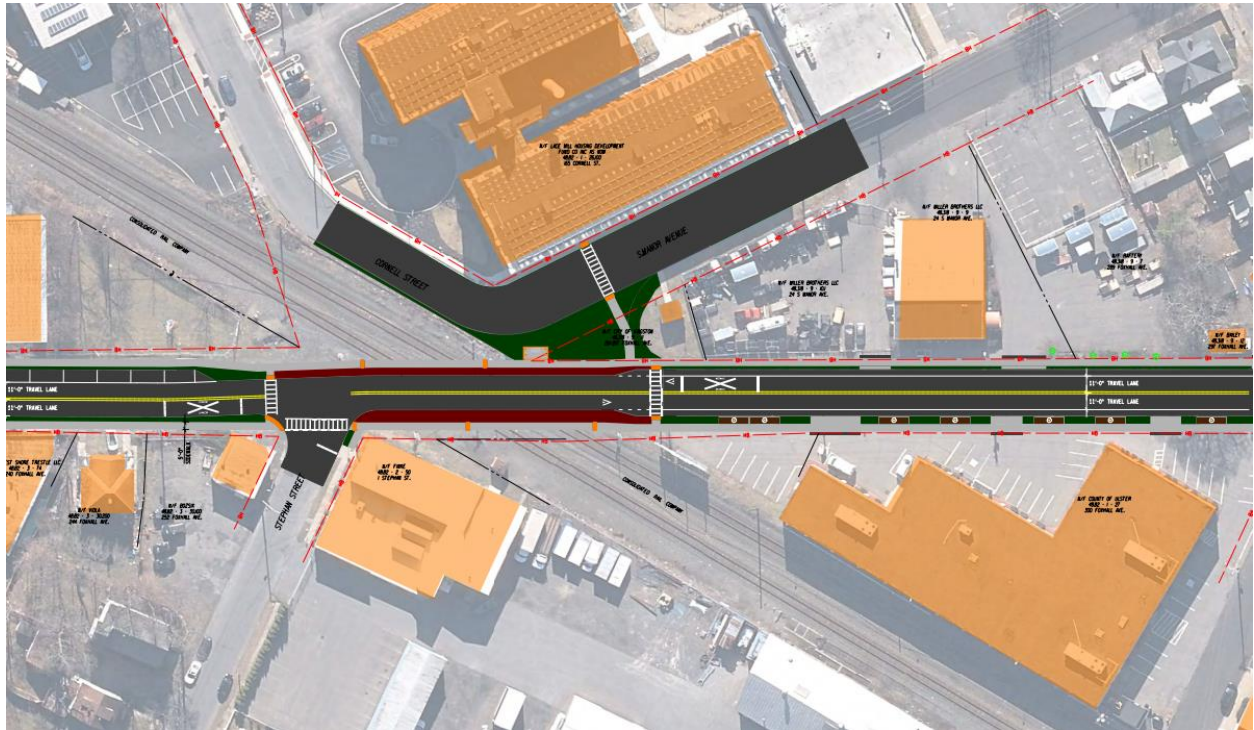
Figure 2-1. Safe and Accessible Flatbush and Foxhall Project Conceptual Improvement

According to the project website, these streets currently have intermittent sidewalks and railroad crossings that can be hazardous for pedestrians and cyclists. Approximately 2 miles of sidewalks will be rehabilitated, and painted crosswalks with Americans with Disabilities Act (ADA)-compliant curb ramps will be installed. Repairs and upgrades will be made all along the route from the intersection of Flatbush Avenue and Colonial Drive to Foxhall Avenue and Broadway. Accommodations for bicycles will also be added along both avenues, connecting to other infrastructure projects, including the Empire State Trail and the Kingston Greenline, which is a network of rail trails, complete streets, and linear parks that winds throughout the city.

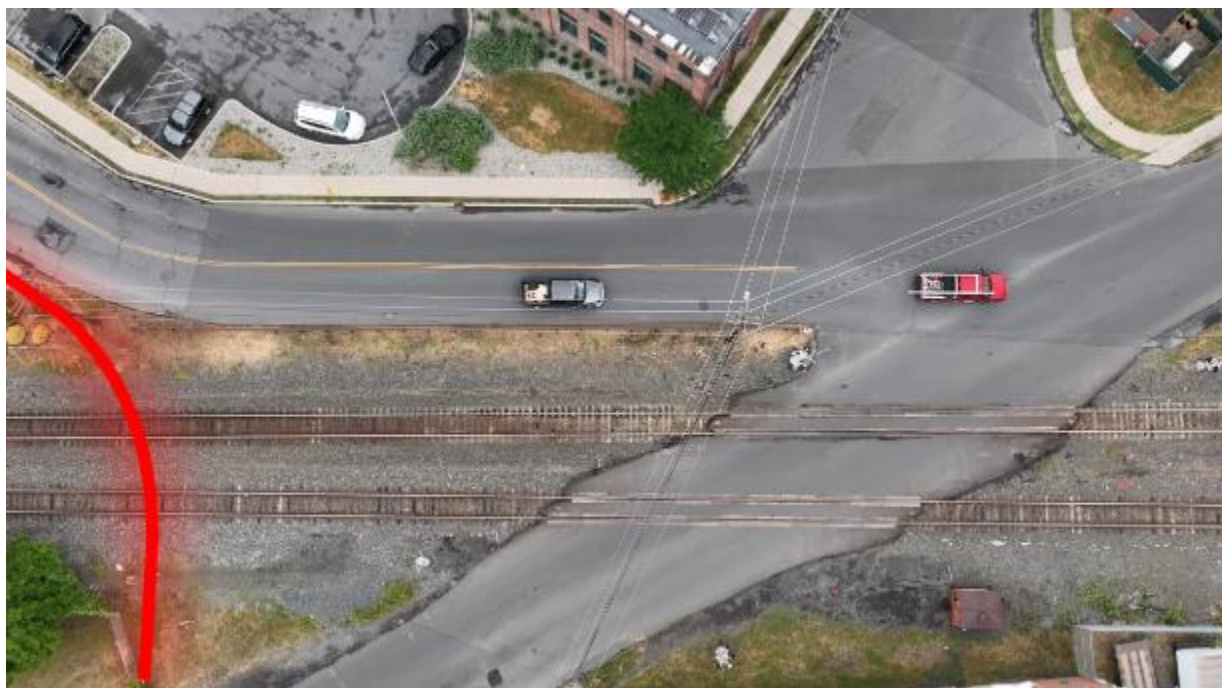
Figure 3-1. Pedestrian Pathway at Foxhall Avenue

In early 2020, the City of Kingston hired GPI Construction Engineering Company to design the Safe and Accessible Flatbush and Foxhall Avenues Project, which aims to improve pedestrian and bicycle infrastructure that connects the Colonial Gardens Apartments and residential streets in Midtown to surrounding business districts. To improve overall pedestrian and traffic safety at this location the proposed improvements would eliminate the ability for the pedestrians to access the tracks, provide safe sidewalk pathways for pedestrians, and eliminate the confusion to motor vehicles. The current design and site improvement proposed in the 2020 report should continue.

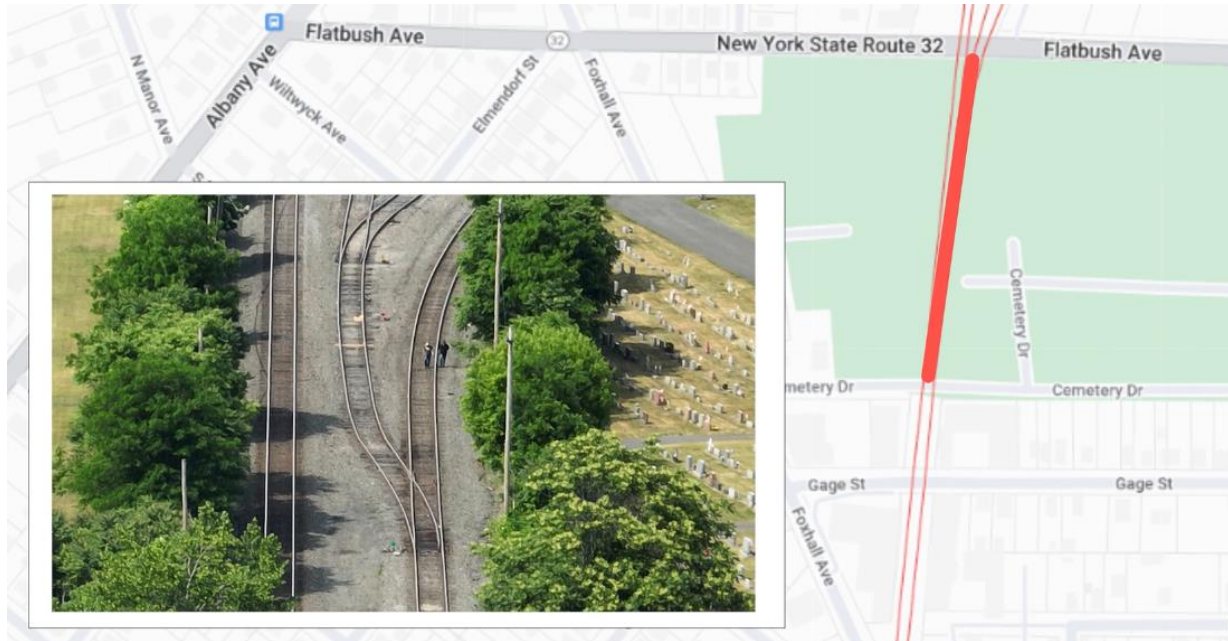
Figure 3-2. Active Trespassing Location near St. Mary's Cemetery

In consecutive field visits, trespassing was observed between the highway-rail grade crossing at Cemetery Drive and Flatbush Avenue (Figure 3-2). There are known destinations to the north of St. Mary's Cemetery that make this area a desirable short cut. There are visible pedestrian paths along the tracks between these two crossings (Figure 3-3).

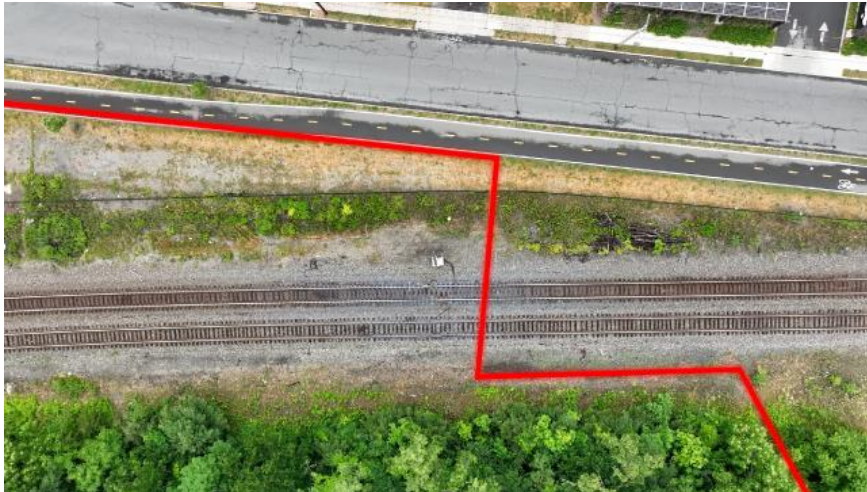
Figure 3-4. Pedestrian Trespass Path South of Broadway

South of Broadway there are no designated crossings at track grade. Broadway provides a protected grade-separated means to cross the tracks, but this adds several minutes, and the majority of individuals are using the tracks as a short cut. Individuals trespass the rail right-of-way to cross from west of the rail line to access Kingston High School and the local YMCA facility located east of the Rail Line (Figure 3-4).

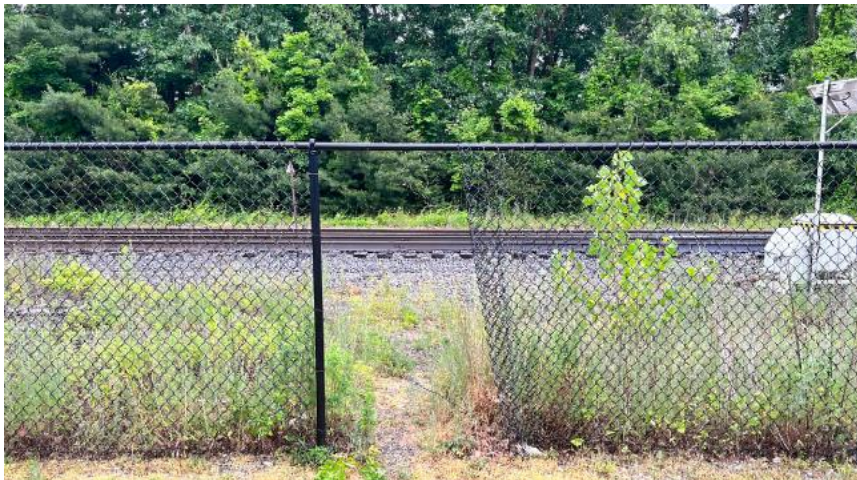
Figure 3-5. Damaged Fencing South of Broadway

Traditional chain link fencing was erected in this location to manage this trespass activity, but the fencing was damaged by the public to allow the activity to resume (Figure 3-5).

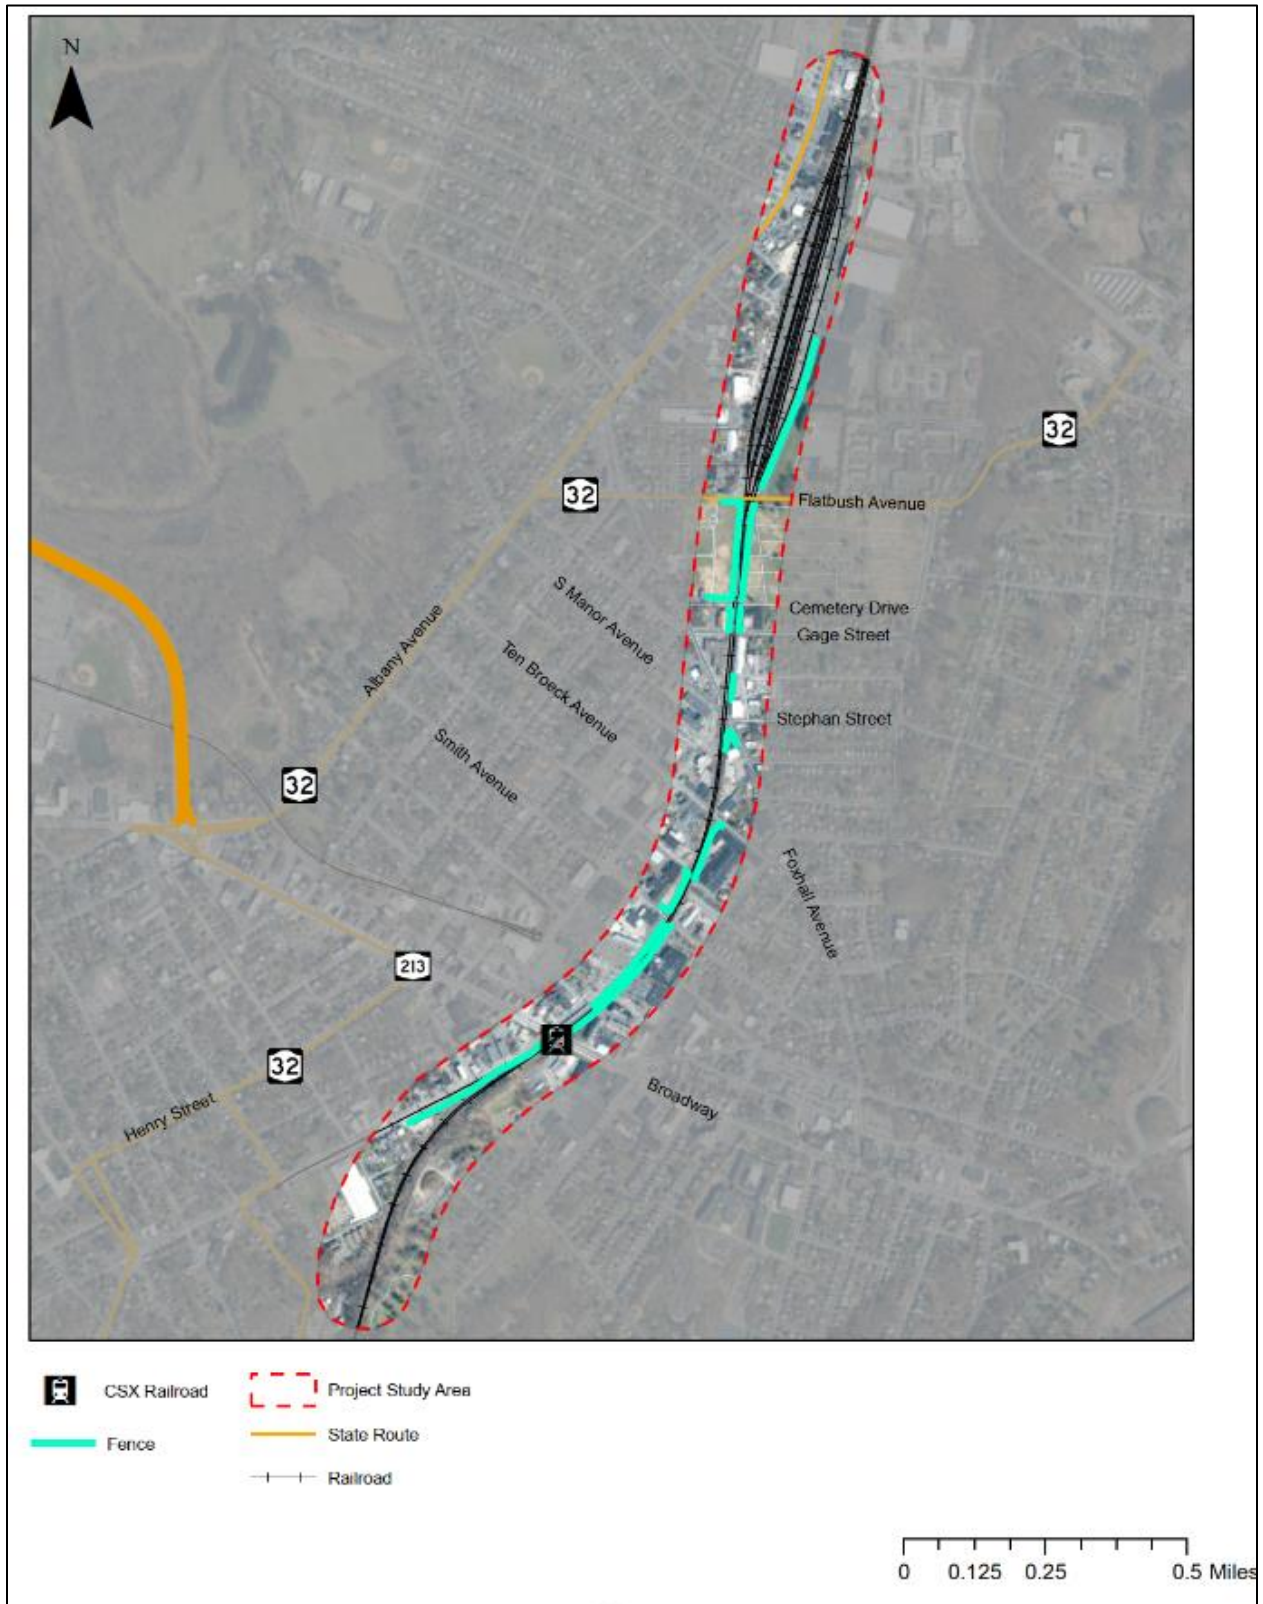
Figure 3-6. Existing Fencing Along the Rail Corridor.

Fencing, a primary mitigation for trespassing, can be easily compromised by determined trespassers. It is important to provide fencing that is effective for the situation, as well as safe and easily accessed alternative pathways. There is existing fencing along the rail corridor in the study area. Figure 3-6 provides a map designating the existing fencing along the rail corridor. The existing fencing is in various states of condition, and some has been damaged to support the illegal track crossing south of Broadway. Traditional chain link fence serves as a barrier, but it can be easily damaged and compromised by individuals. The height of the fencing also determines its success as a mitigation. Fencing 48 inches or lower does not deter all individuals from scaling the fence. Fencing in excess of 72 inches will deter more individuals. There are also alternative fencing products and barriers that are difficult to alter, rendering them more effective as a trespass mitigation solution. These options are further discussed in Section 5.1.3.

South of Broadway, CSX installed traditional chain link fencing in the area where trespassers were crossing the tracks to access Kingston High School and the YMCA. Shortly after the installation of this fence, sections of the fence were damaged to allow trespassing to continue. CSX also installed “No Trespassing” signs along the rail corridor.

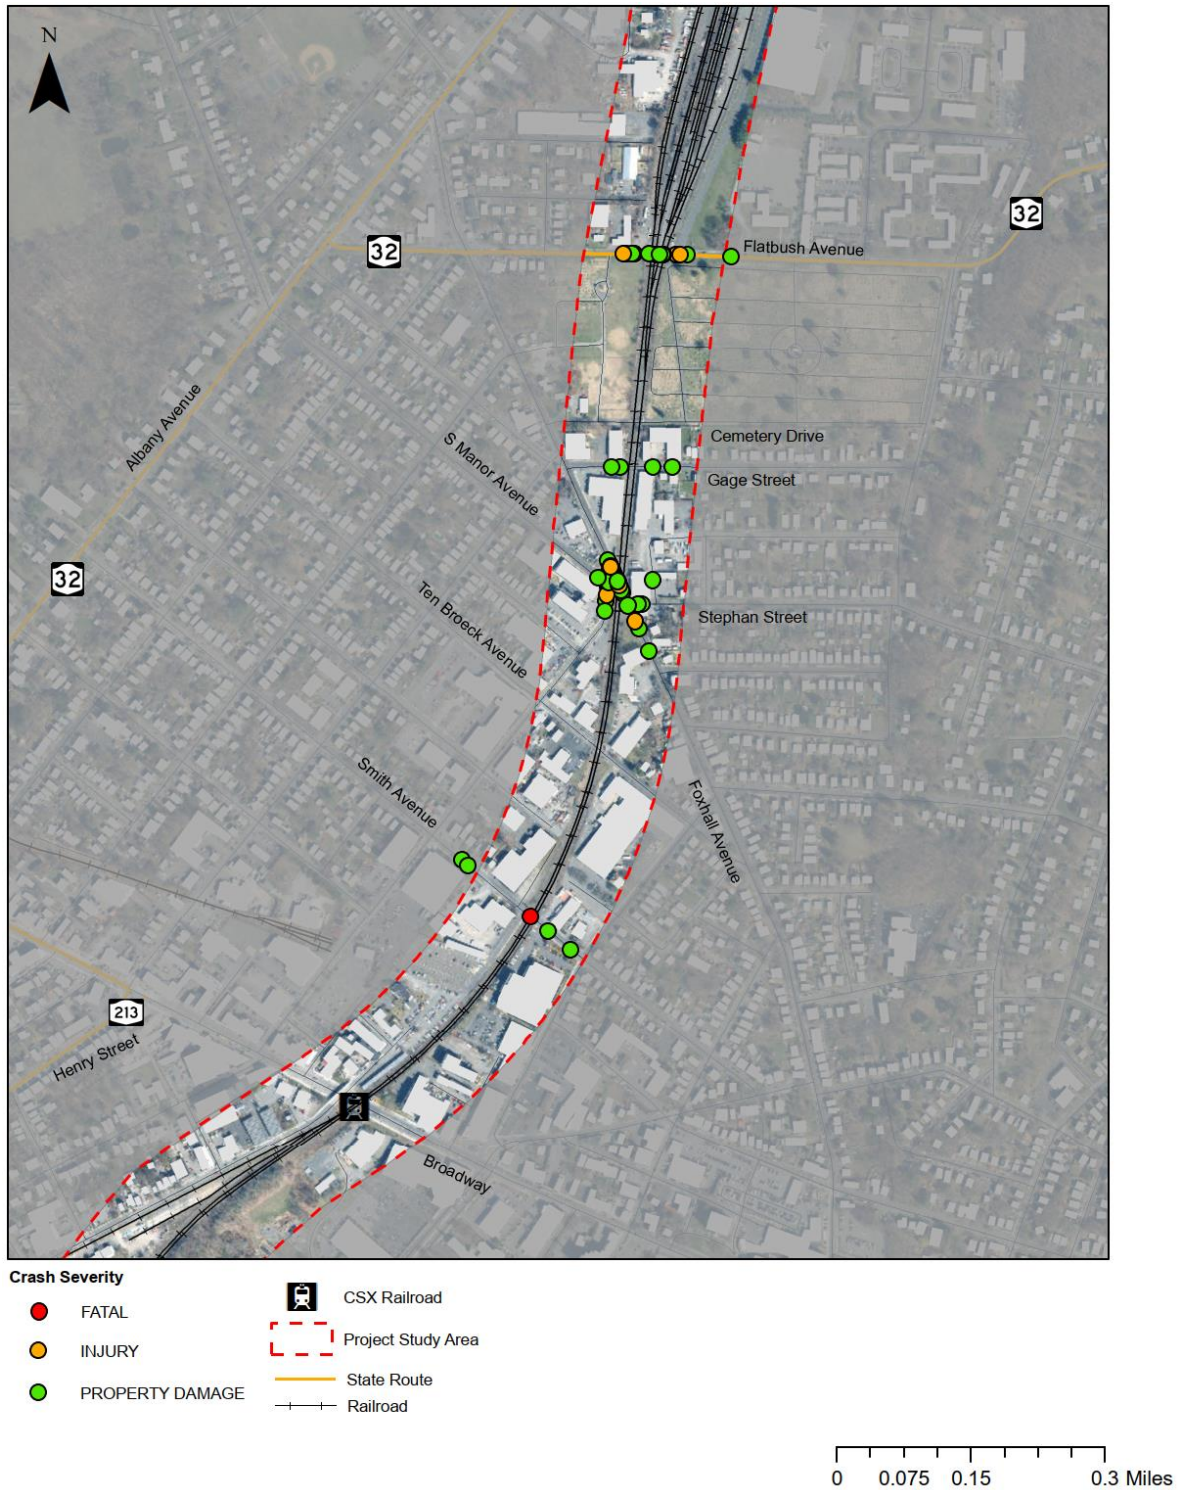
Figure 3-8. Highway-Rail Grade Crossing – Crash Severity

Location	Fatal	Injury	Property Damage Only
NYS Route 32/Flatbush Avenue	0	4	9
Cemetery Drive	0	0	0
Gage Street	0	0	4
Foxhall Avenue	0	12	36
Ten Broeck Avenue	0	0	0
Smith Avenue	1	0	4

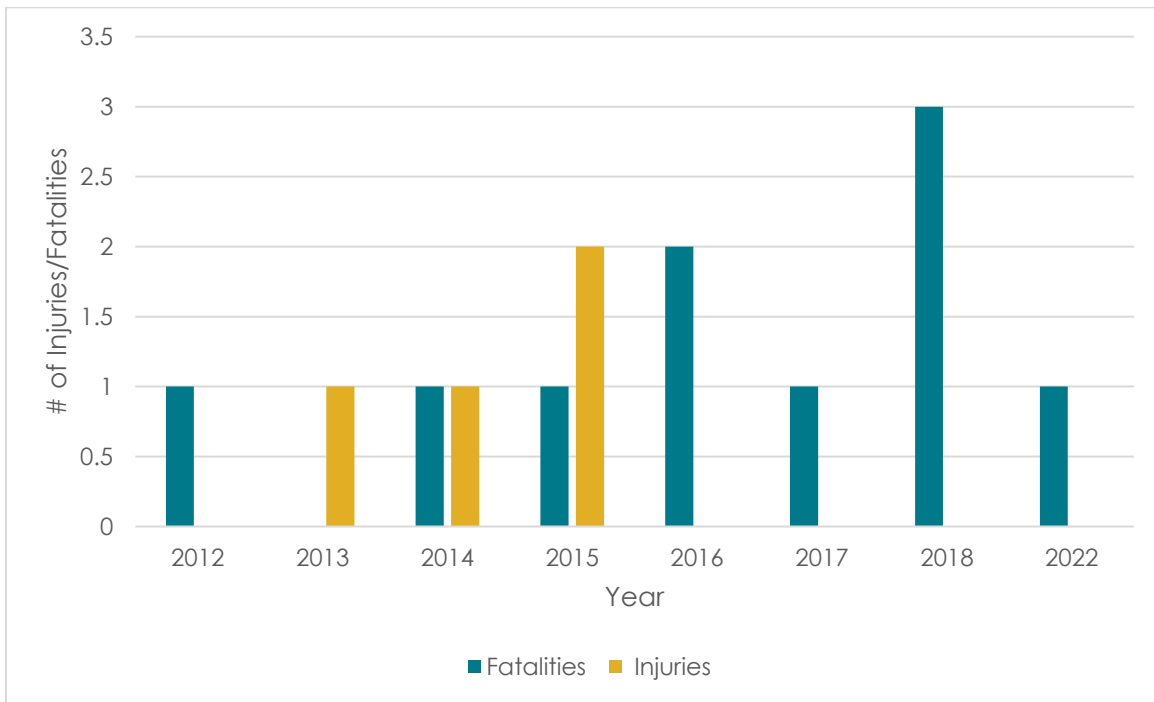
Figure 3-25. Trespassing Injuries/Fatalities by year (10-year History)

The FRA data on trespassing incidents goes back to 2012 and is current to 2022. For that 10-year period there were 14 incidents of a trespassers being struck along the right-of-way in Ulster County. Out of the 14 incidents, 10 resulted in a fatality and 4 resulted in injury to the trespasser. Figure 3-25 shows the breakdown of fatalities and injuries by year. This study did not determine how many of the fatalities were a result of suicide.

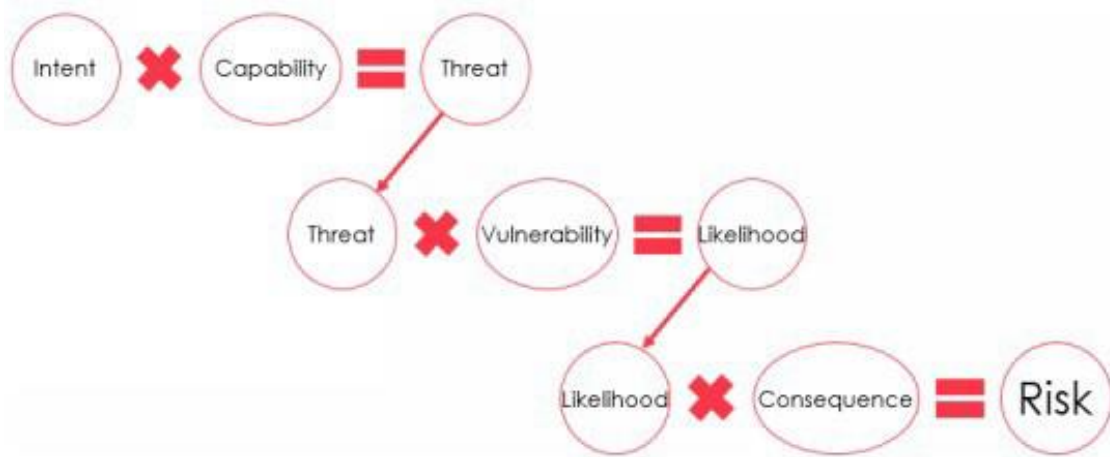
Figure 5-5. Threat and Vulnerability Assessment Flow Diagram

The threat and vulnerability assessment process employed includes an assessment of intent and capability to establish threats, an assessment of threats and vulnerabilities to establish likelihood, and

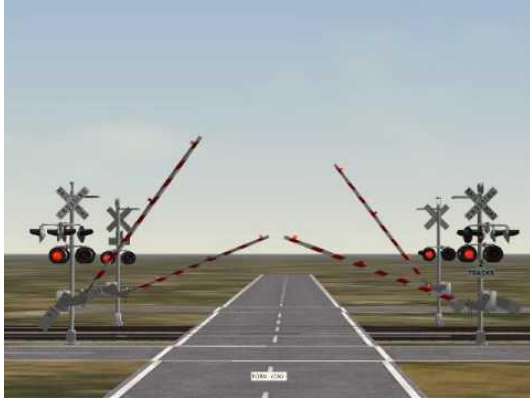
Quad Gates

Figure 5-12. Engineering Solutions for Active Warning Device Improvements

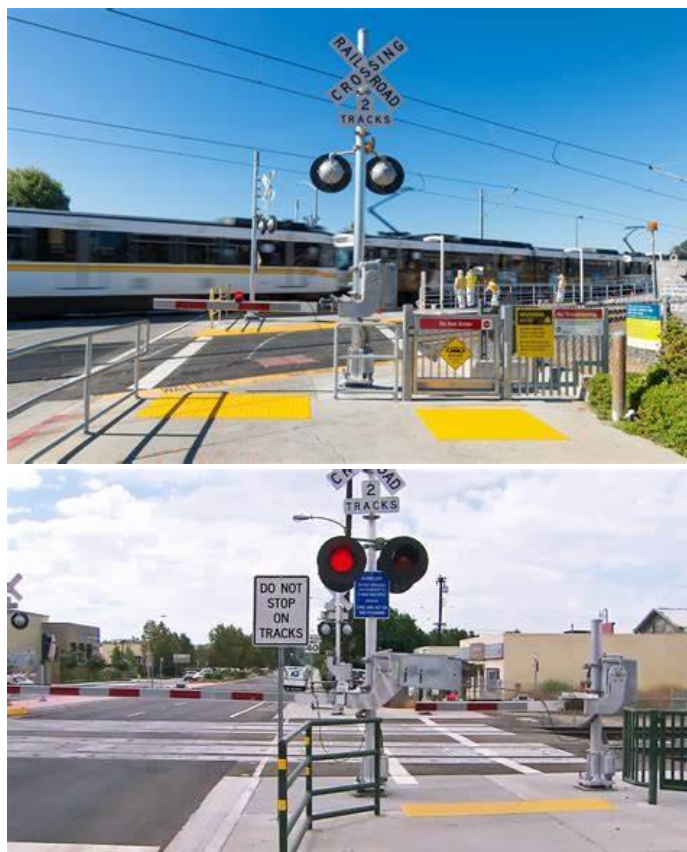
Figure 5-13. Examples of Pedestrian Grates and Sidewalks

In addition to gates that protect the roadway, pedestrian gates and signage help protect pedestrians when traversing over a highway-rail grade crossing. Ideally dedicated sidewalks in conjunction with pedestrian gates provide a safer option for pedestrians (Figure 5-13).

Appendix F provides concept renderings showing how these active pedestrian gates and sidewalk improvements could be implemented to improve the safety for pedestrians and drivers at both the Flatbush and Ten Broeck Avenue highway-rail grade crossing

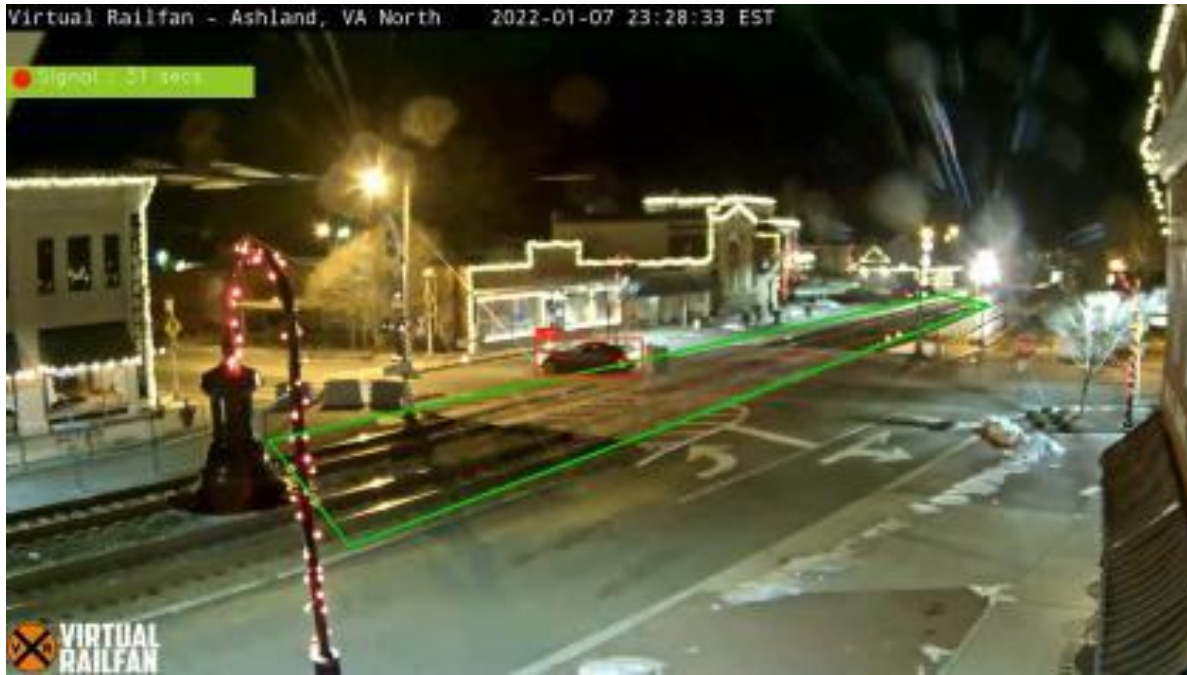
Figure 5-15. Example of Video Technology with AI Analysis

Video analysis utilizing artificial intelligence (AI) in concert with closed-circuit television (CCTV) cameras is a newer approach to detecting unsafe behavior at crossings. This technology can not only help detect this behavior but can also notify proper authorities when the unsafe activity is occurring. AI-aided framework automatically detects railroad unsafe events, differentiates types of violators, and generates video clips of infractions. The system uses an object detection algorithm to process video data into a single dataset (Figure 5-15).

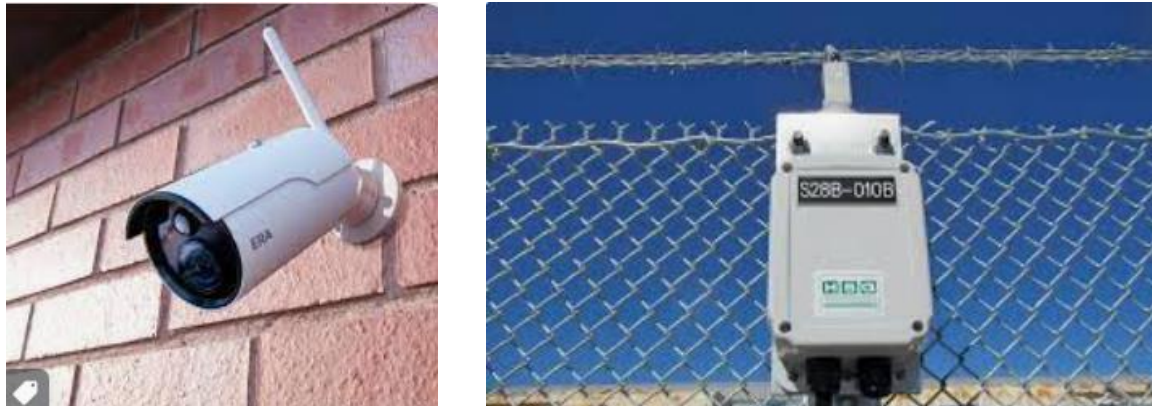
Figure 5-18. Examples of Enforcement Technology Solutions

Railroad rights-of-way are private property, and it is illegal to trespass on train tracks. Enforcement of violators is key to reduce the likelihood of trespassing events. When railroad and community law enforcement agencies partner and work together, proactive mitigations can stop and deter this illegal behavior. For the local law enforcement agencies to be successful the railroads need to educate them on the problem areas and provide incident data so police can focus their enforcement efforts at the correct areas along the right-of-way. Additional utilization of technology like CCTV cameras and intrusion detection with AI can help identify unusual occurrences along rail corridor, help tend hot spots, and notify the proper authorities when unusual activity is occurring (Figure 5-18).
